SUBJECT: INFORMING THE ASSEMBLY OF THE COMPLETED PLANNING ASSISTANCE FOR STATES (PAS) TECHNICAL REPORT FOR TALKEETNA EROSION ASSESSMENT DECEMBER 2023 BY THE USACE

Planning Assistance to States
Technical Report

Talkeetna Erosion Assessment Technical Assistance

Talkeetna, Alaska

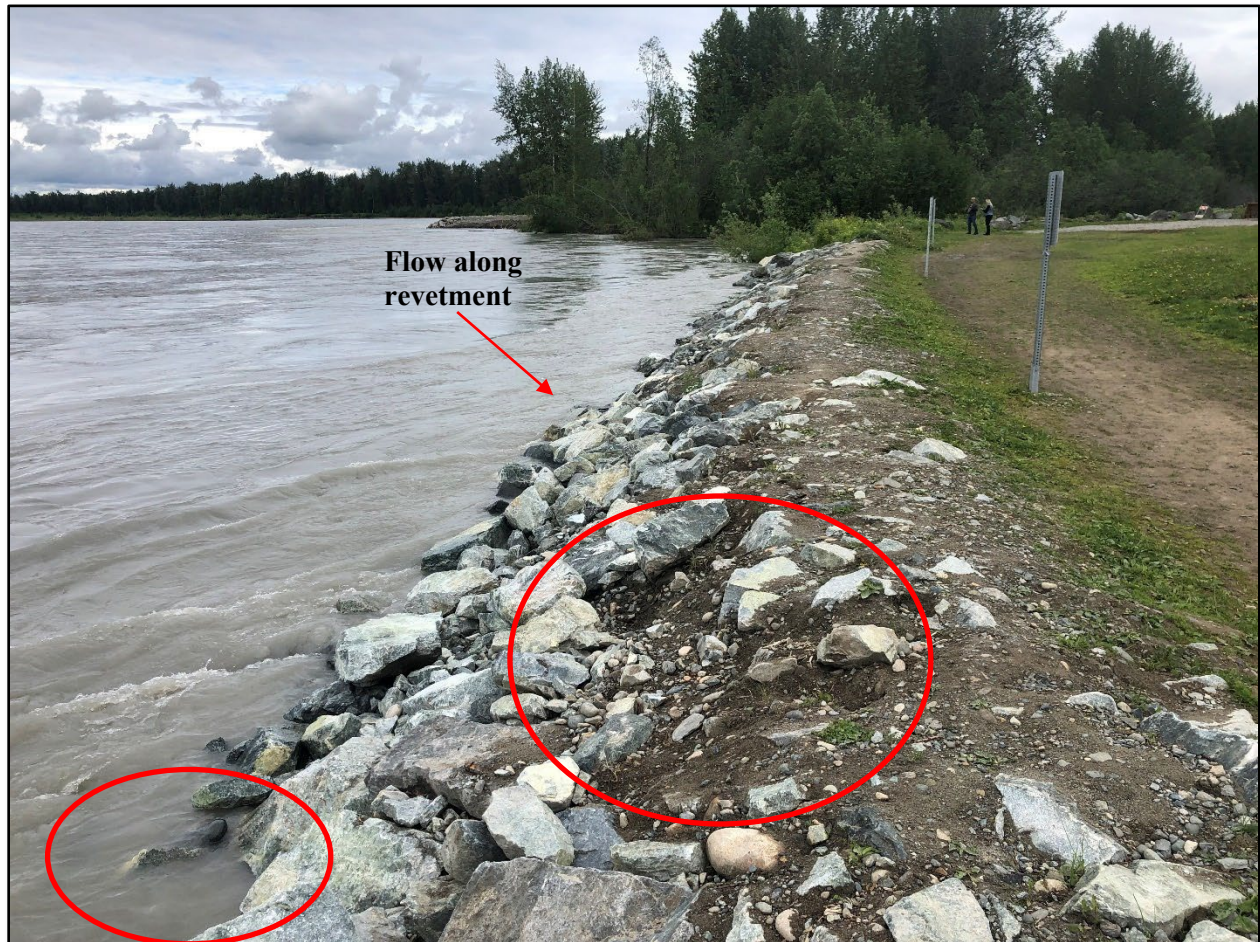
These structures have experienced significant erosion since they were built (Figures 9-11), with most of the erosion occurring after the 2012 flood when the main stem of the Susitna River shifted to flow against the east bank. An engineered design repair was needed on the dike extension after the 2012 flood and was completed by FEMA in 2017. Emergency repairs were needed due to severe erosion along the dike extension and revetment in 2020 and was performed by the Matanuska-Susitna Borough (Figure 12). Severe erosion is occurring at the confluence of the Talkeetna River and Susitna River after the dike extension (Figure 13), where a large and deep eddy has formed since 2017 which was measured to be up to 40 feet during the summer.

Figure 9. Erosion and loss of armor stone observed along revetment in 2021.

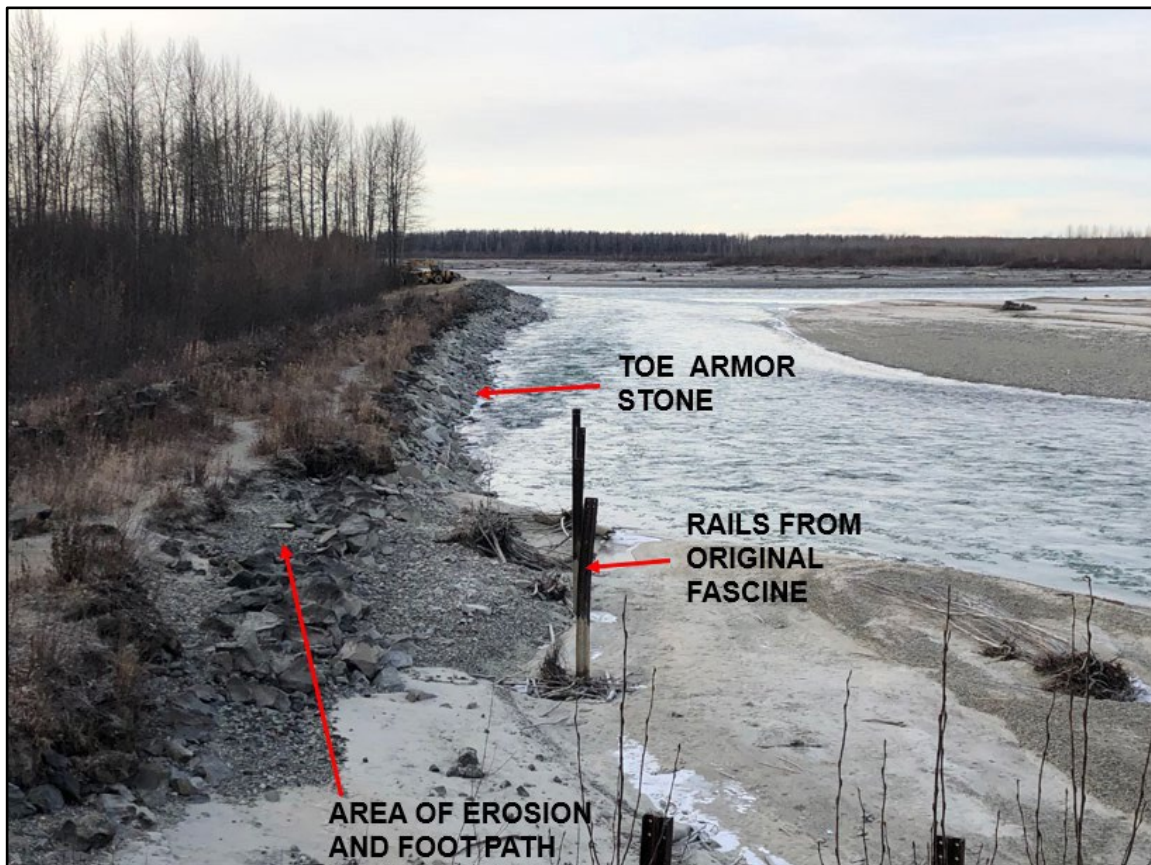
Figure 10. Erosion of dike observed during low water in 2020.

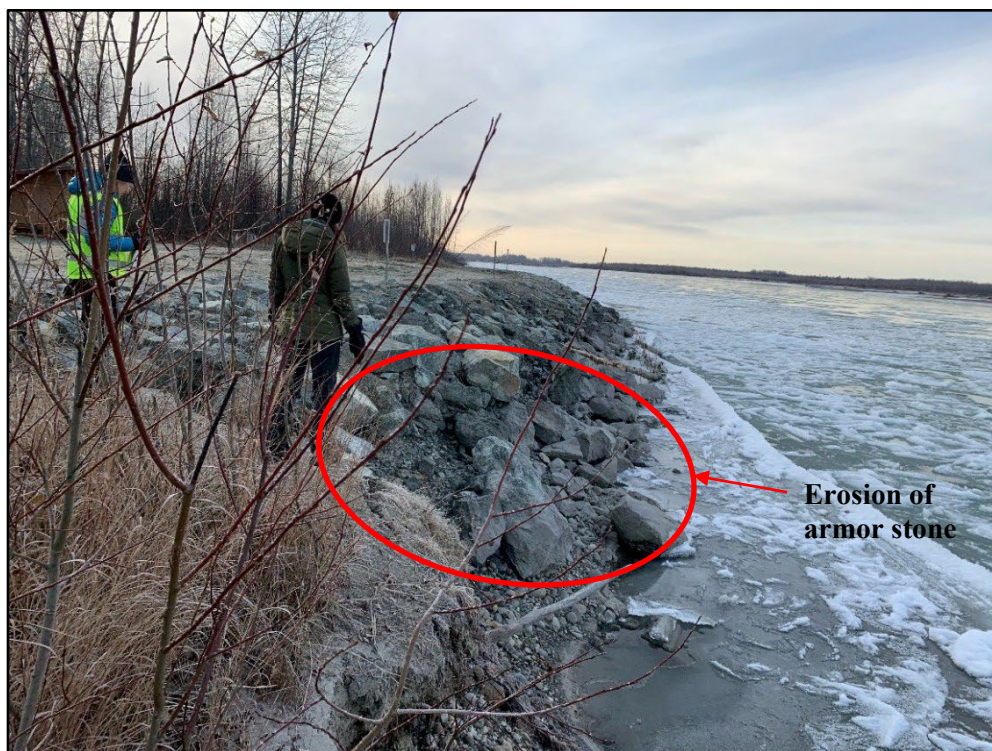
Figure 11. Erosion of armor stone along revetment observed in 2020.

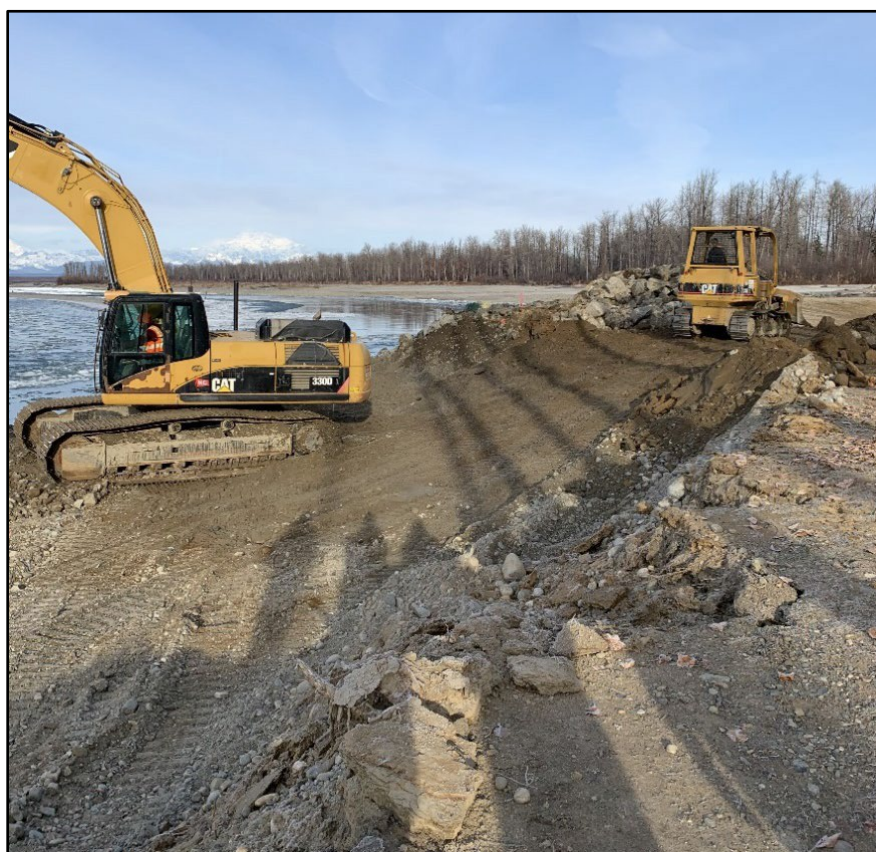
Figure 12. Emergency rock placement occurring along dike extension in 2020.

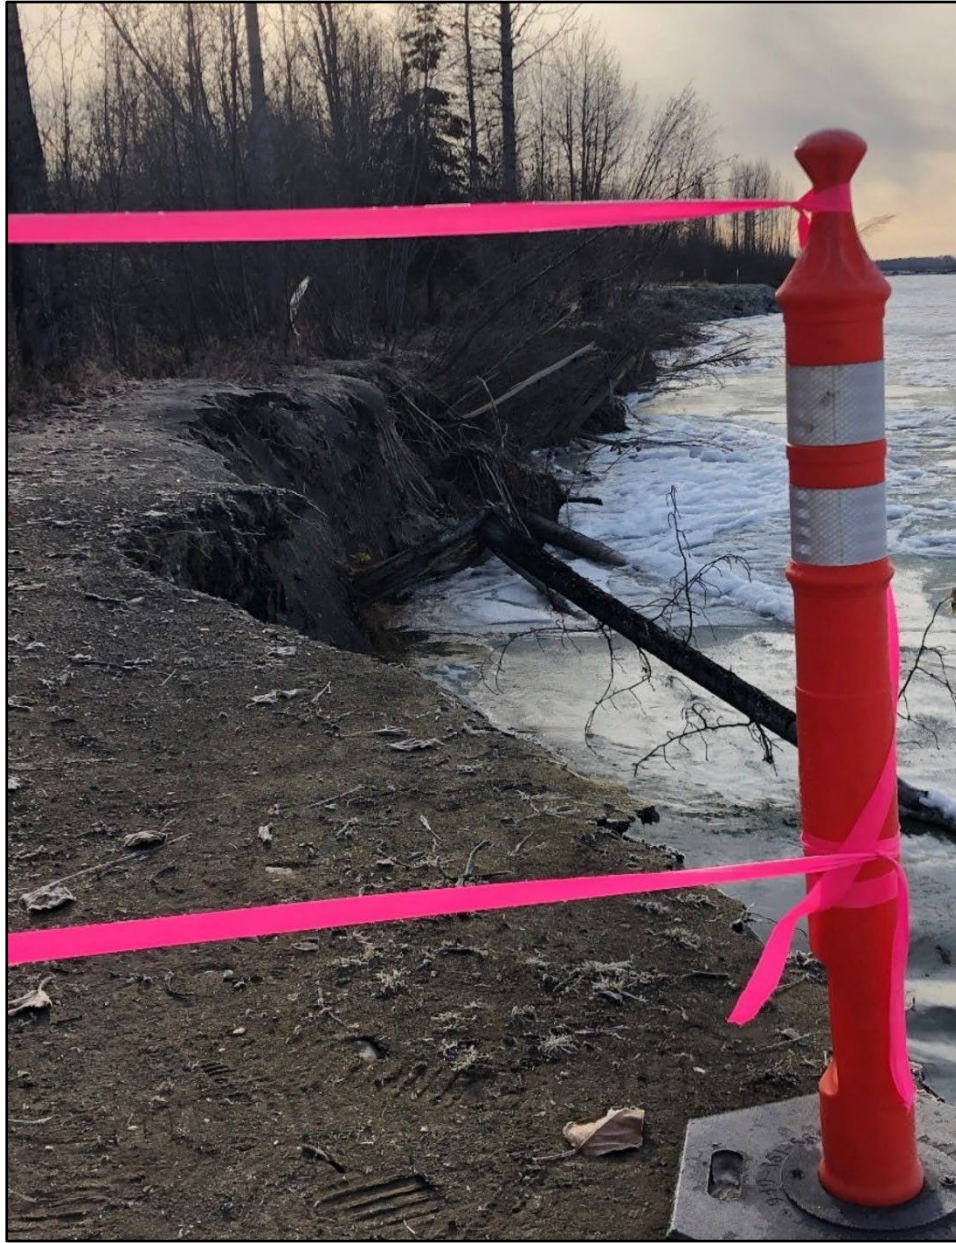
Figure 13. Erosion occurring at the confluence of the Talkeetna River and Susitna River after the dike extension observed in 2020.

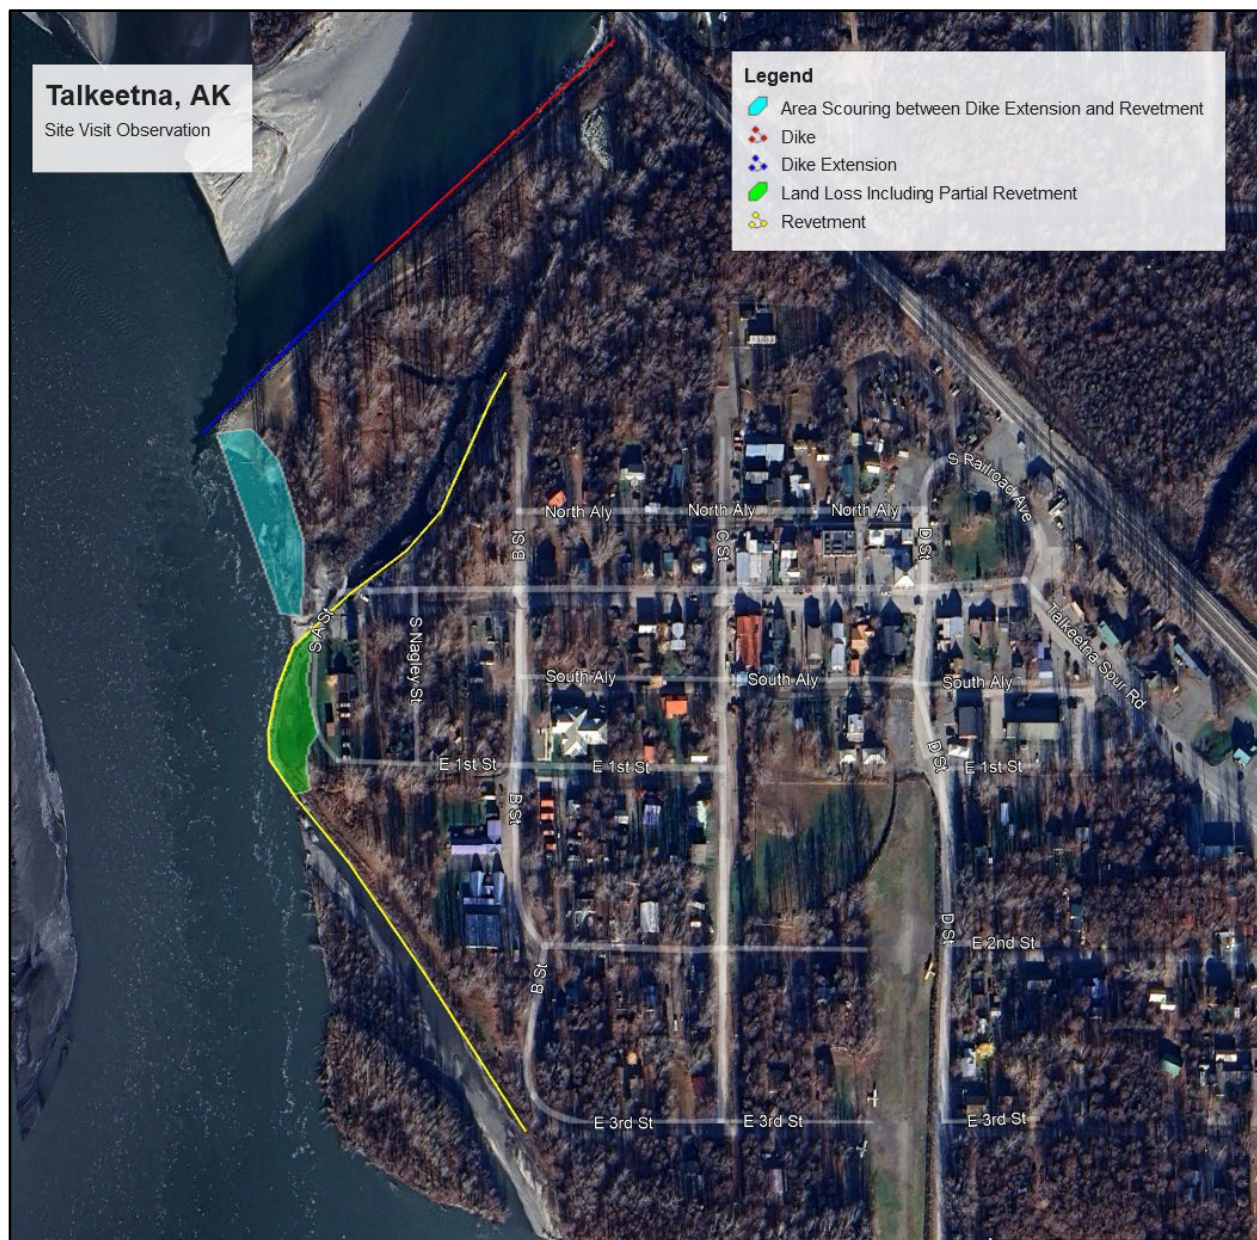
On 07 September 2023, MSB-PW received a report from the Talkeetna Fire Chief that the riverbank had experienced significant erosion overnight, putting additional risk upon existing cabins along A Street (Figure 8). Four days later, the MSB-PW and USACE representatives met in Talkeetna to conduct an assessment. It was estimated that the river claimed 65 feet of land overnight, consistent with MSB-PW staff photos taken on 05 September 2023 and visual observation. The erosion removed a portion of the revetment along A Street from East Main Street to East First Street (approximately 325 feet). While in Talkeetna, MSB-PW staff reviewed the National Weather Service gage for the Talkeetna River at the railroad bridge (TKTA2). The gage had peaked at 11.10 feet (343 feet NAVD88) around 9:00 AM that morning, was receding, and forecasted to continue to decline in the coming days. The discharge along the Talkeetna River gage (U.S. Geological Survey (USGS) gage 15292700) which is located roughly 2 miles upstream from the confluence with the Susitna River, peaked at 38,000 cubic feet/second (CFS) around 12:00 AM on 27 August 2023. Multiple smaller peaks occurred until 06 September 2023 when the flow finally started to decline. The Susitna River gage at Gold Creek (USGS gage 15292000) had a peak discharge of 48,000 CFS on 02 September 2023 at 6:15 AM. This gage is approximately 37 miles upstream from the confluence of the Chulitna River and Susitna River. Based on hydrologic analyses, the peak flow for both gages were roughly a 5-year return period. The Chulitna River gage near Talkeetna (USGS gage 15292400) was disabled in the year 2016.

Figure 14. Locations of scour and land loss in Talkeetna, September 2023.

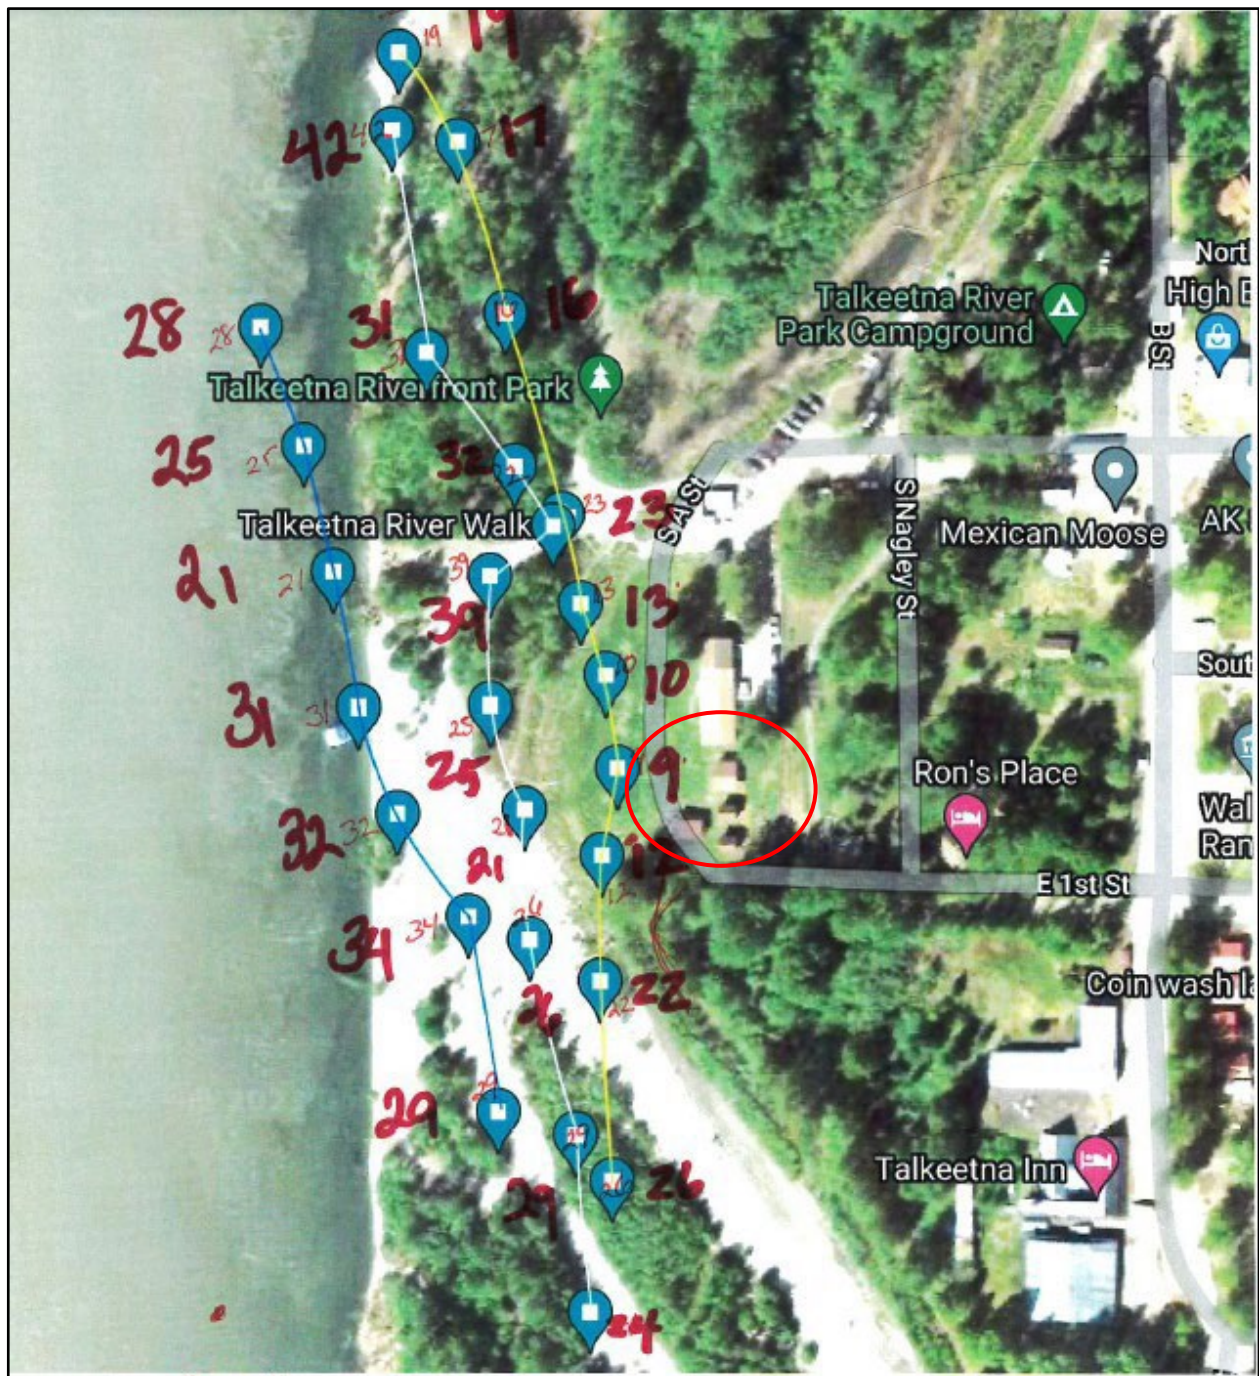
Figure 15. Water depth survey conducted 17 September 2023.

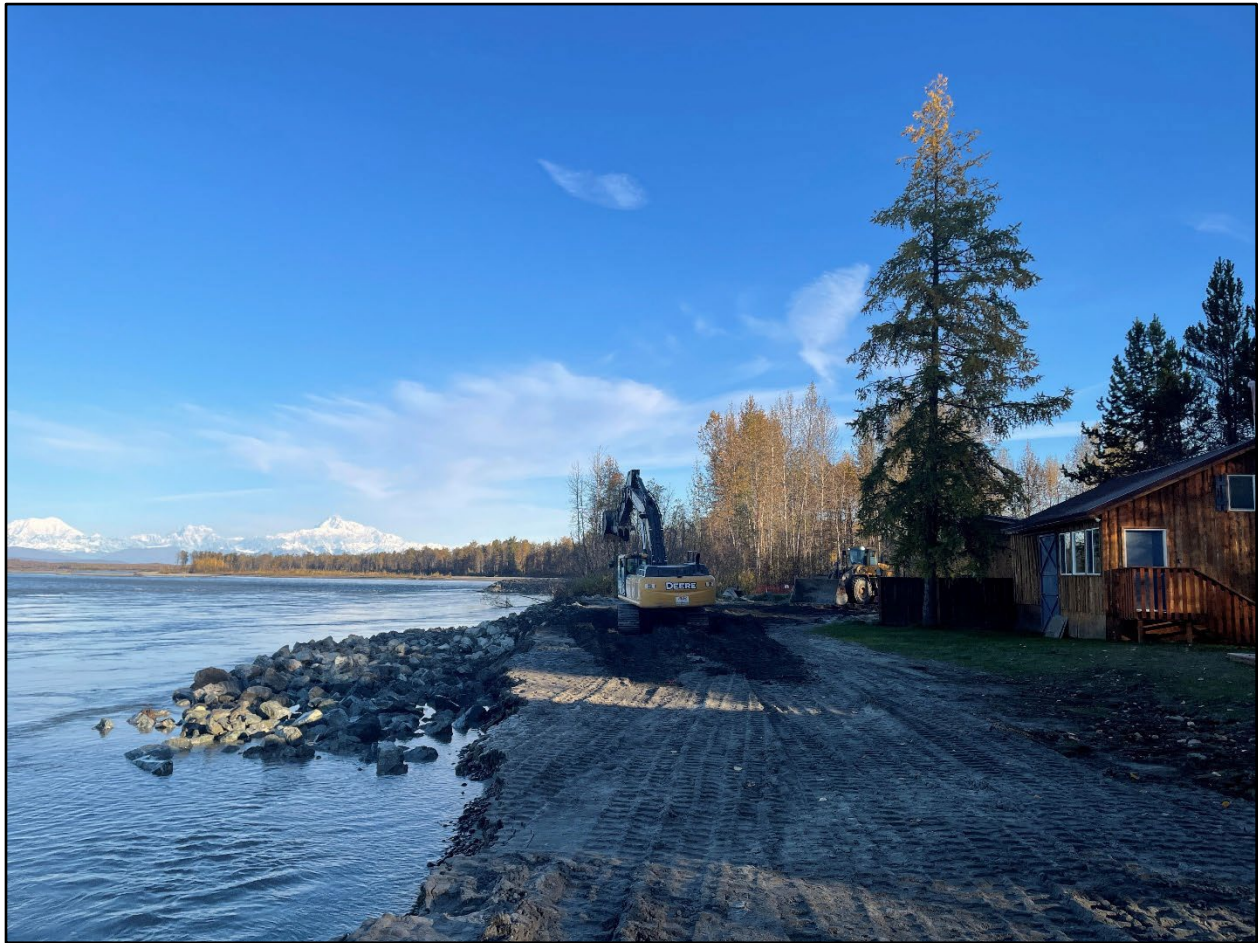
Figure 16. Emergency placement of revetment material following early September 2023 flood event.

The Matanuska-Susitna Borough authorized transporting 900 tons of rock to the end of Main Street to stage for anticipated repairs to the revetment. As the Susitna River subsided, a water depth survey was conducted on 17 September 2023 in preparation for emergency repairs (Figure 15). The cabins shown in the red oval in Figure 15 are the cabins shown in Figure 16 after the early September 2023 erosion event. Repairs were conducted in late September 2023, and the as built for this repair can be seen in Figure 17.

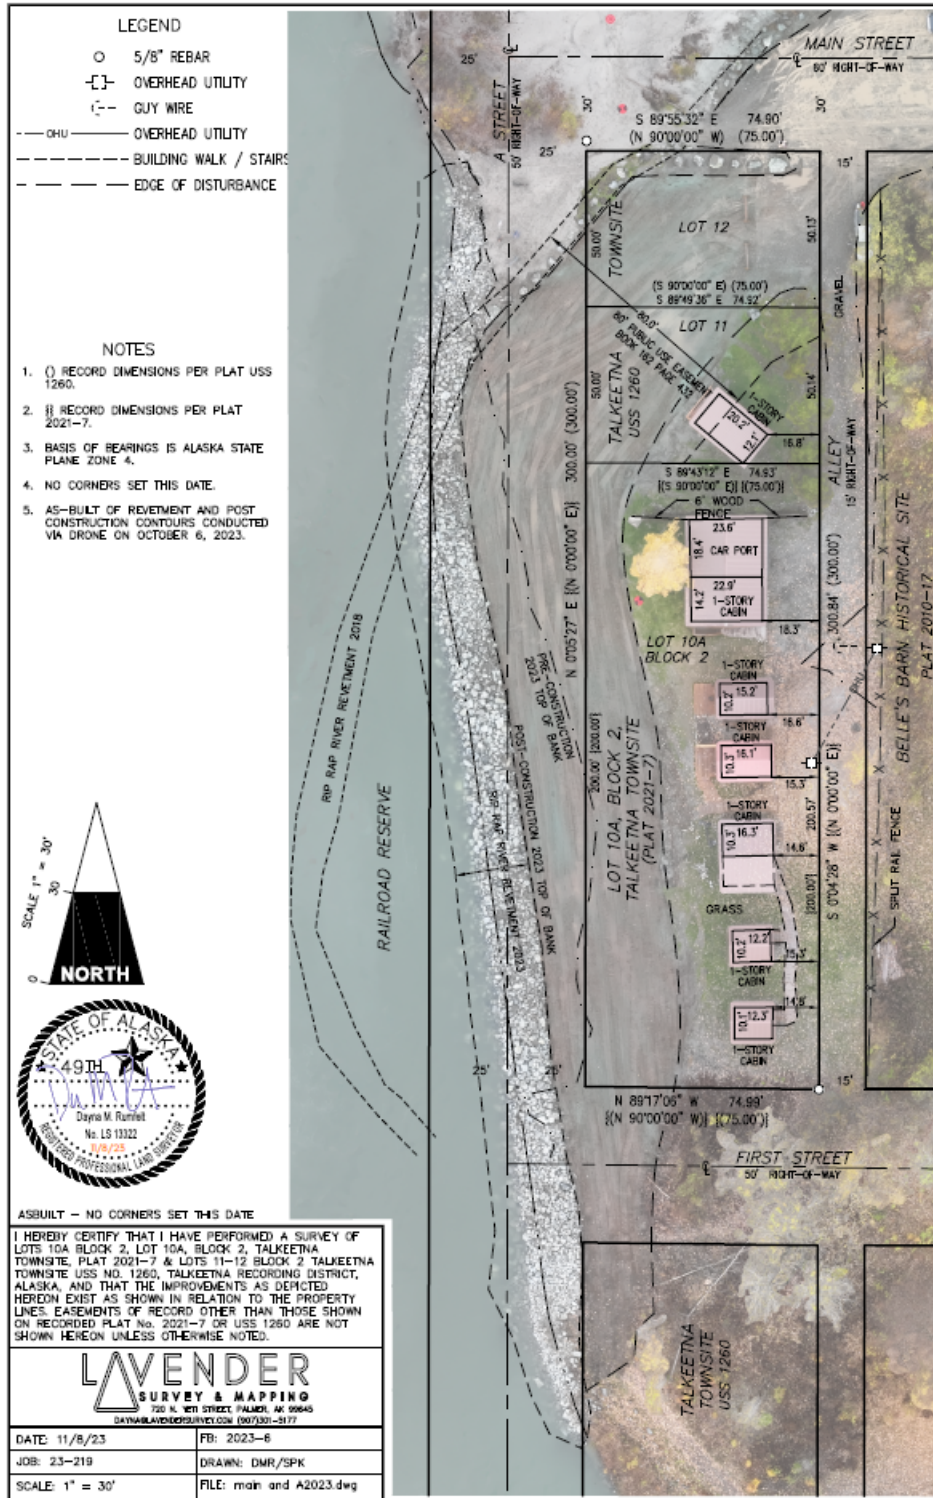
Figure 17. Final as-built for emergency repairs (as-built dated 08 November 2023).

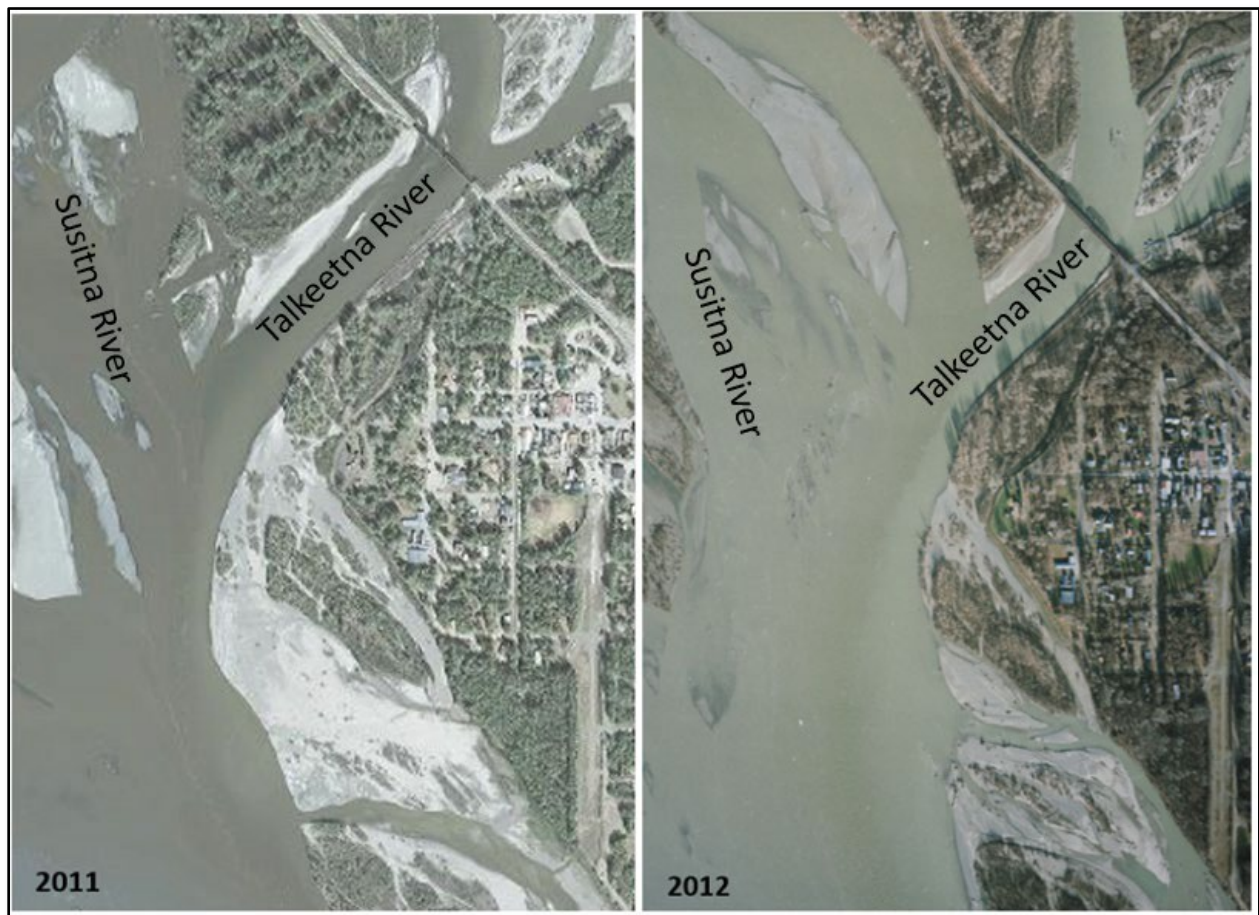
The Susitna River is a large, glacially fed, braided river system with a high sediment load of fine silts and sands. Rivers of this nature are very dynamic, and one flood event can completely change where the main stem of the river flows due to the intense amount of erosion and accretion that takes place during a large flood. The Susitna River is a prime example of this, with the main stem of it changing course after the 2012 flood (Figure 18). Before this flood, the main stem of the Susitna River flowed to the west, away from downtown Talkeetna. There was also large amounts of accretion of fine sands and silts in front of the revetment and dike extension due to less flow in this area. After the flood, the main stem shifted and now flows east, with the main stem directly hitting the end of the dike extension and running along the current revetment, enhancing the erosion along these banks. See Appendix A for an aerial photograph time series of this confluence from 1953-2022.

Figure 18. Susitna and Talkeetna River Confluence Pre and Post 2012 Flood.

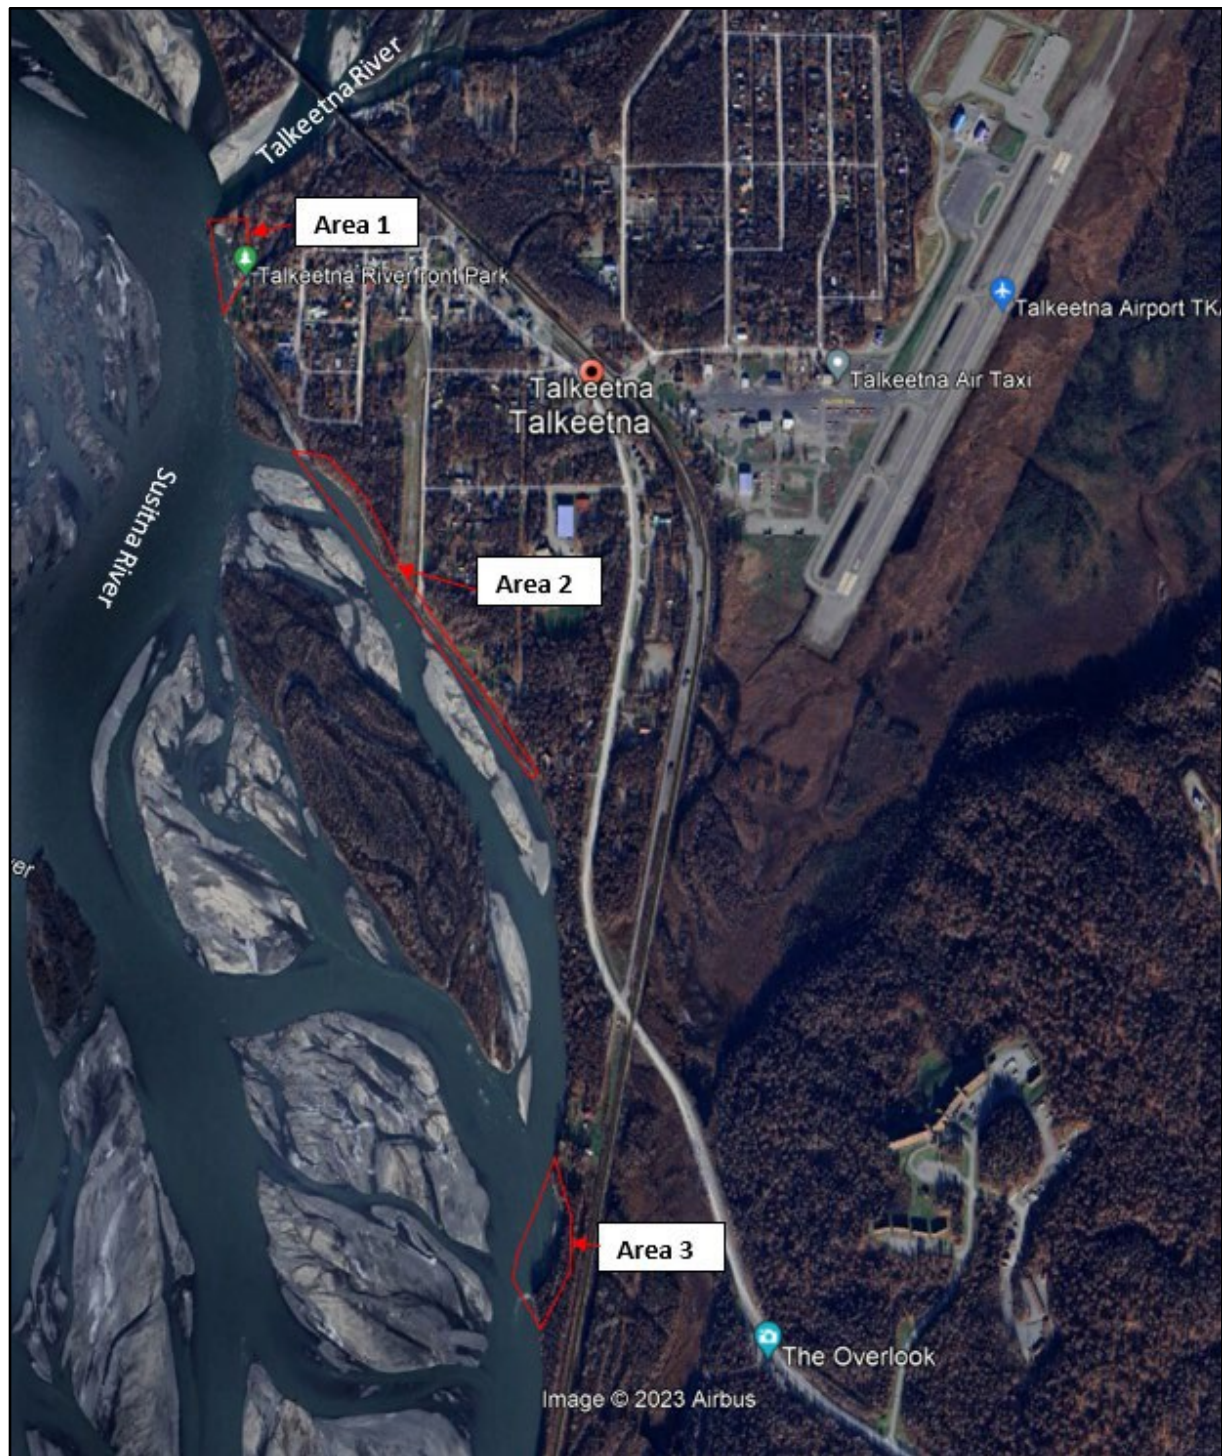
From these analyses, three main areas were identified with the highest erosion rates (Figure 24) that should be the focus of any potential erosion reduction efforts. Areas 1 and 2 are located at the end of the previously constructed erosion mitigation structures (i.e., dike extension and revetment). Area 3 is land owned by the Alaska Railroad. Area 1 includes Stations AOI 3-6; Area 2 includes Stations 215+00 to 250+00; Area 3 includes Station 265+00.

Figure 24. Areas with the highest erosion rates (Google Earth Imagery, 2022).

USACE Alaska District recommends the use of rock revetments, like the one shown in Figure 25, for long term streambank erosion protection.

The intent of this report is to provide information that can assist the non-Federal sponsor in identifying a potential erosion protection project. The USACE Alaska District recommends a rock revetment for long term streambank erosion protection. Information and data presented in this PAS study will be used to support a Section 14 feasibility study in Talkeetna (if funded), and any other future riverine erosion protection projects within the Talkeetna area.
