SUBJECT: Disposal of Port MacKenzie conveyor system.

# Port MacKenzie Conveyor Valuation

Inspection and Valuation Report

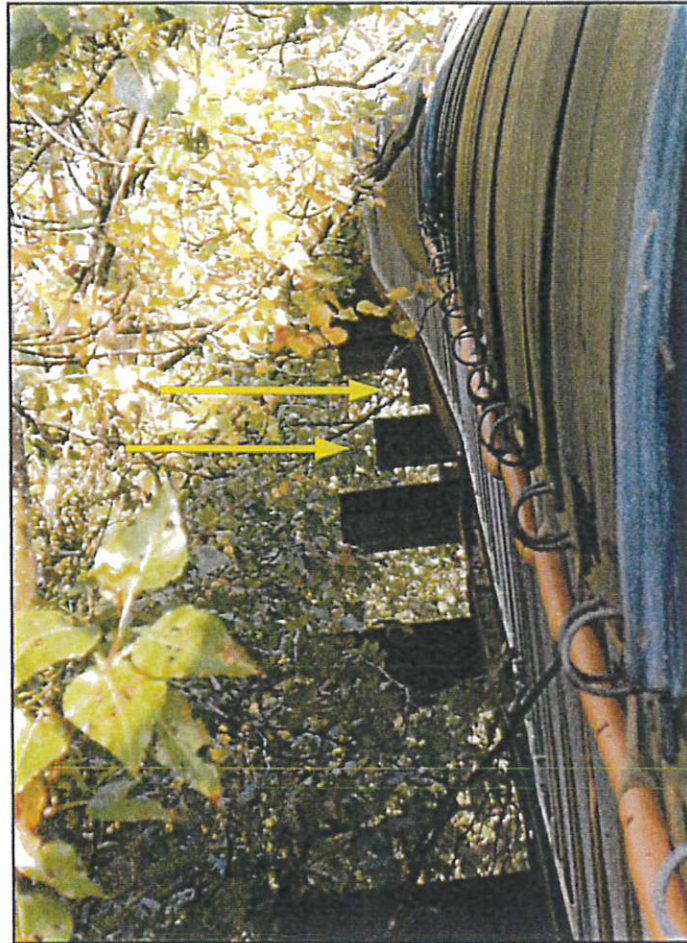
Figure 2: Conveyor and Support Pile Out of Alignment

Lateral movement was observed on two of the downhill conveyor support piles. This pile movement has resulted in the conveyor being pulled out of alignment (Figure 2). Piles are identified numerically in this report and are numbered sequentially beginning at the bottom end of the downhill conveyor run (before its entrance to the CMP tunnel) upward, at pile #1.

Based on the September 2019 inspection findings, pile #8 has moved approximately 7" out of alignment in the downhill direction, and the pile #9 cap appears to have moved approximately 19" out of alignment in the downhill direction. Movement was estimated based on relative distance between the conveyor trestle and angle brackets attached to the pile cap (Figure 3).

Due to the significant pile displacement observed, it is recommended that this deficiency be addressed in both short-term and long-term phases. The rate at which the piles have shifted is unknown, so it cannot be estimated conclusively how long remains before the piles shift to a point where the conveyor trestle is no longer supported by the pile cap. Movement may have been caused slowly due to slope and/or pile creep or due to seismic activity in the area. Poor drainage at the bottom of the hill may also be contributing to pile movement; therefore, a long-term solution including drainage improvements is recommended to mitigate pile movement. The following actions are recommended:

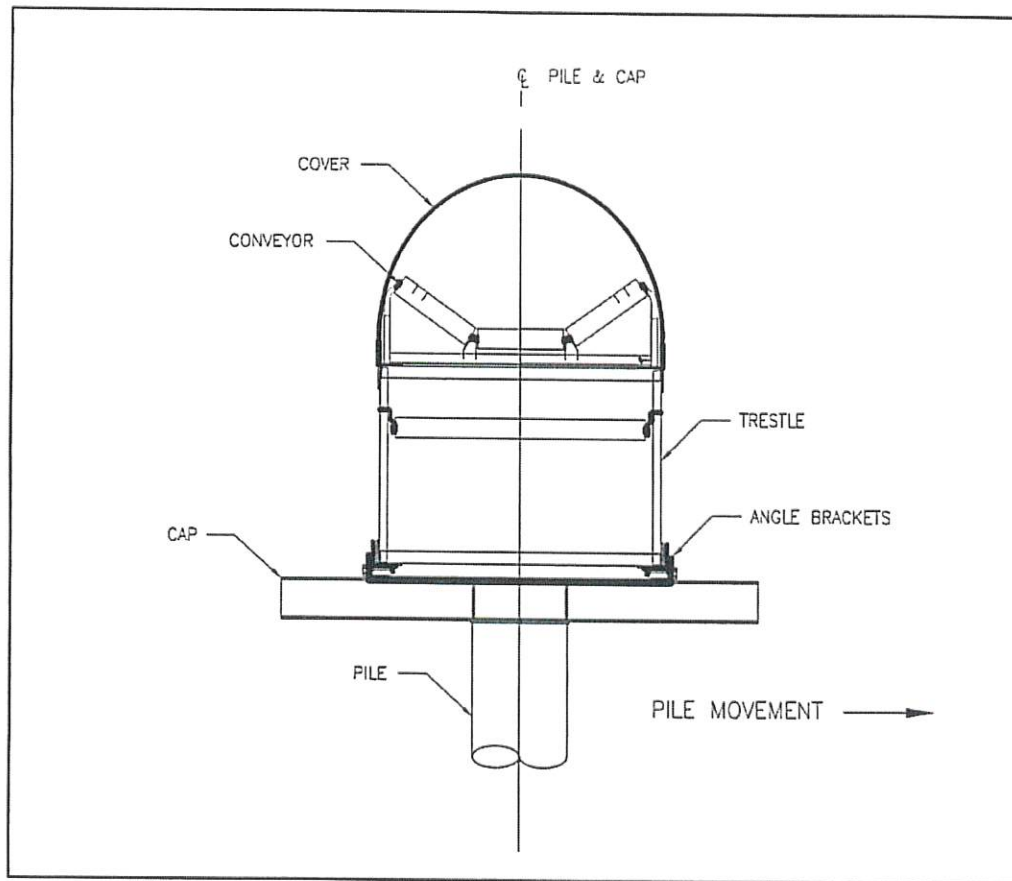
Figure 3: Conveyor and Downhill Support Section

Although the angle brackets serving to guide the conveyor trestle appear to have followed the lateral movement of the pile and cap to an extent, the movement of the pile cap relative to the trestle appears to have exceeded the angle brackets' original installed position at both pile #8 and pile #9. This indicates that the connections between the pile cap and angle brackets may have failed, thereby allowing the pile and pile caps to move freely relative to the angle brackets. Due to lack of access, the condition of these connections could not be confirmed during the inspection.

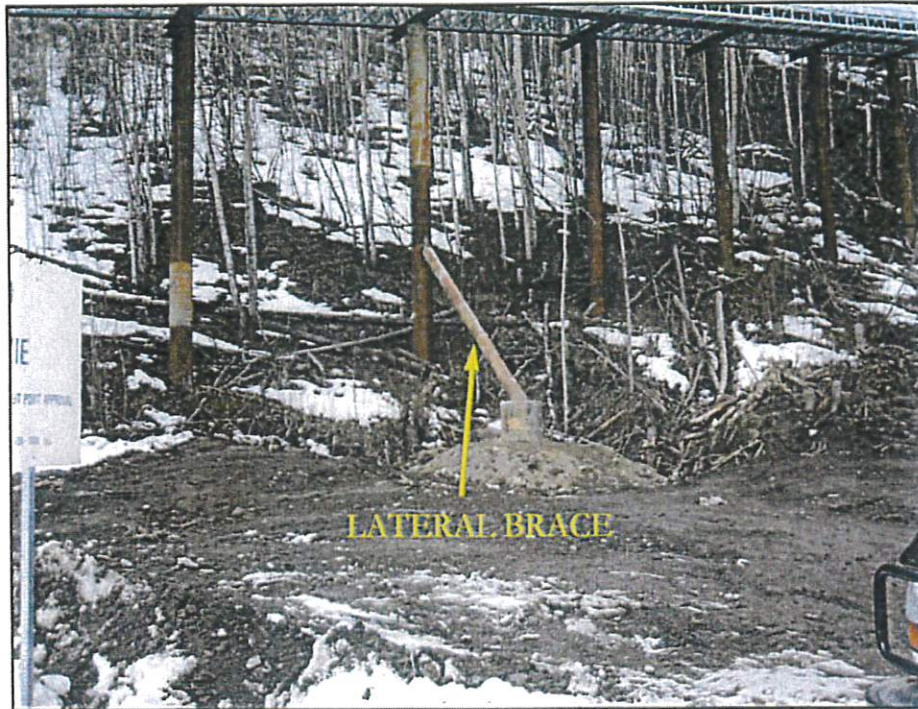
Figure 4: Pile #8 Support Bracing (April 9, 2006)

It should be noted that the support piles for the downhill conveyor were constructed in November 2004, with the downhill conveyor installed the following year in 2005. In early 2006, a new pile was installed adjacent to the conveyor support pile (pile #8 from the south) with a lateral pipe brace (Figure 4). It is speculated the purpose of the lateral support constructed in 2006 was to inhibit downhill movement of pile #8. It is unknown to what extent the pile had shifted at the time of construction of the support, but limited images during original installation appear to show minimal movement

compared to its current condition. PND is unaware of any quantitative monitoring of the pile movement since then.

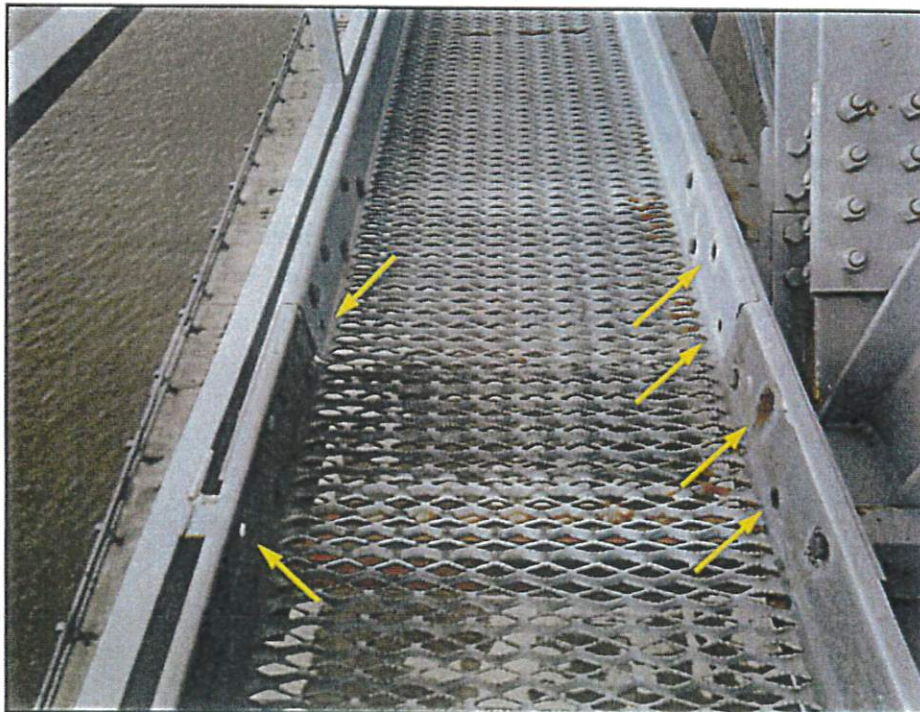
Figure 5: Loose or Missing Toe Board Splice Bolts

Loose and missing bolts were found throughout the catwalk above the dock. Most of these were on the toe boards where splices connected one catwalk segment to the next (Figure 5). Failures at these locations may result in an unsupported catwalk as identified in the area below the hopper (Figure 6).

It is recommended that repairs and/or replacement of the catwalks and connections be made before any other maintenance, construction, or repair crews utilize these for access. The two catwalk segments with restricted access may be too deficient to repair and may be more feasible to replace in-kind.

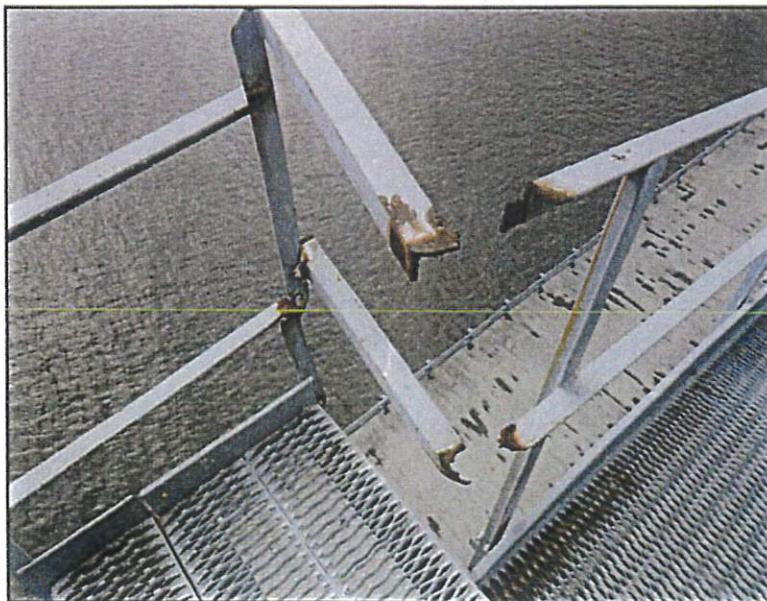
Figure 7: Damaged Catwalk Handrail

Additional damage to catwalks included damaged toe board channels, rail failures (Figure 7), and damaged grating. Damage to the catwalk near the ship loader was extensive enough for structural concern, so the catwalk was taped off to restrict access (Figure 8).

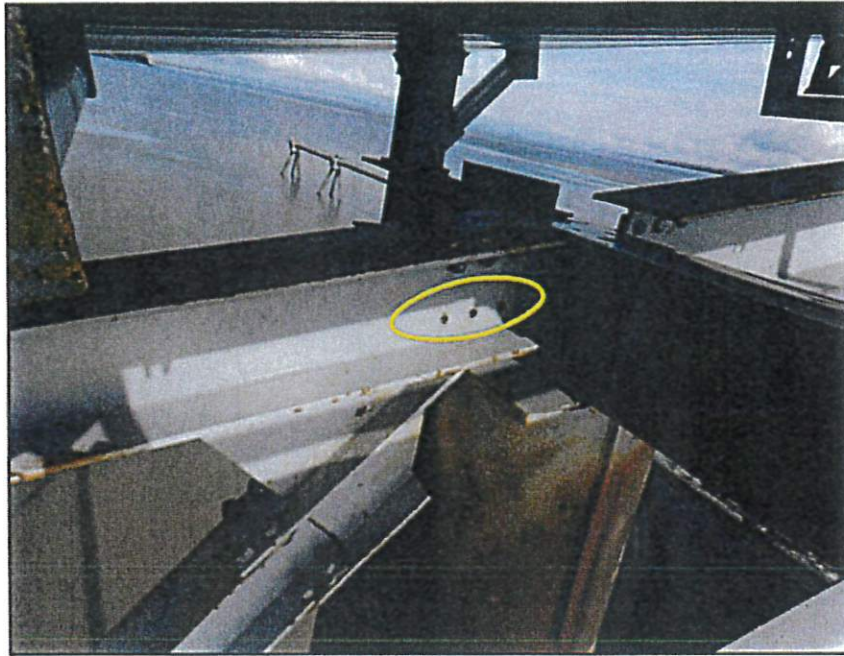
Figure 9: Missing Bolts on Framing Connections Beneath Conveyor

Missing bolts were noted on numerous connections throughout the conveyor superstructure as shown in Figure 9 through Figure 12.

It is recommended that the deficient connections be repaired as soon as practical to ensure the structural integrity of the superstructure.

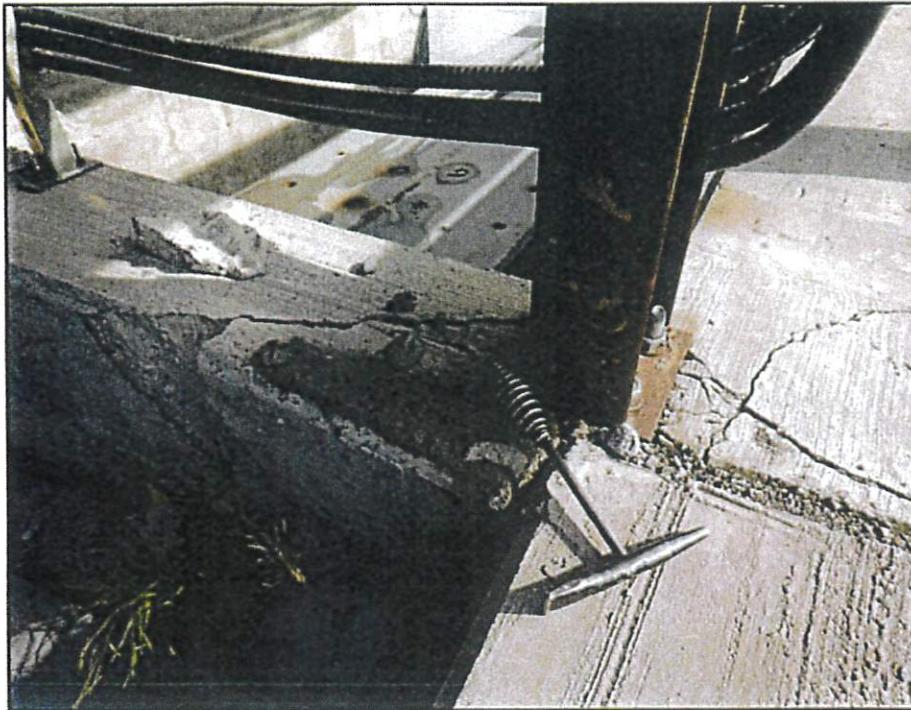
Figure 13: Concrete Damage at Onshore Backwall Conveyor Supports

Supports for the conveyor and superstructure foundation were also observed with varying degrees of concrete spalling, cracking, and loose connections as shown in Figure 13 through Figure 15.

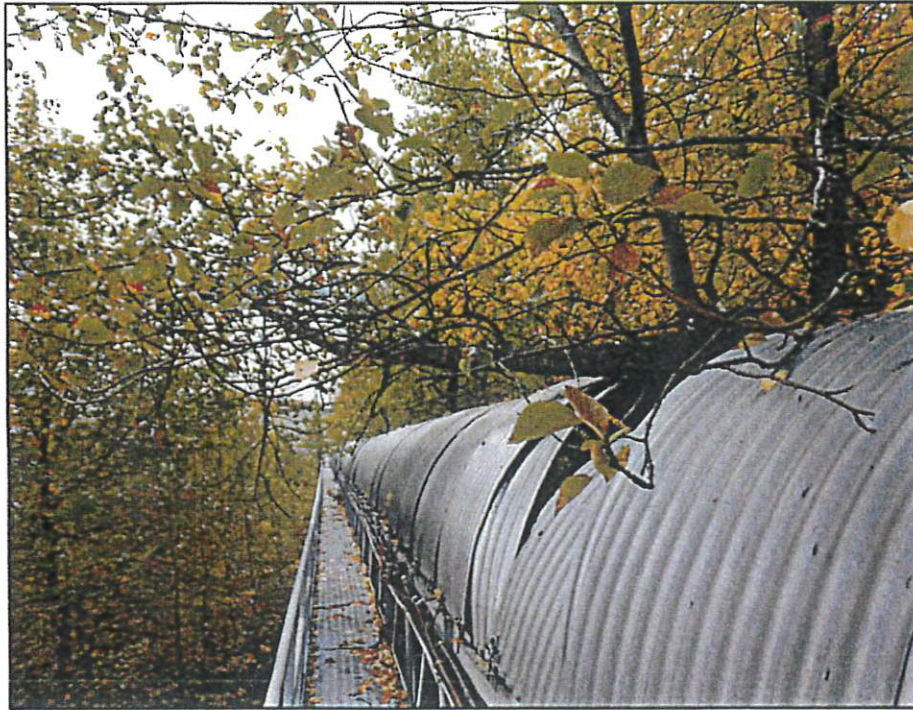
Figure 16: Brush Growth Along Downhill Conveyor Run

There is significant overgrowth of trees and brush around the reclaim and the downhill segments of the conveyor (Figure 16). Vegetation is growing into and through the conveyor infrastructure. Damage was observed on conveyor covers, but no other structural damage was observed due to the overgrowth at the time of inspection. Accessibility to the conveyor was inhibited by brush growth.

It is recommended that the brush below and adjacent to the conveyor infrastructure be removed to allow access to the system and to arrest any further damage to the facilities.

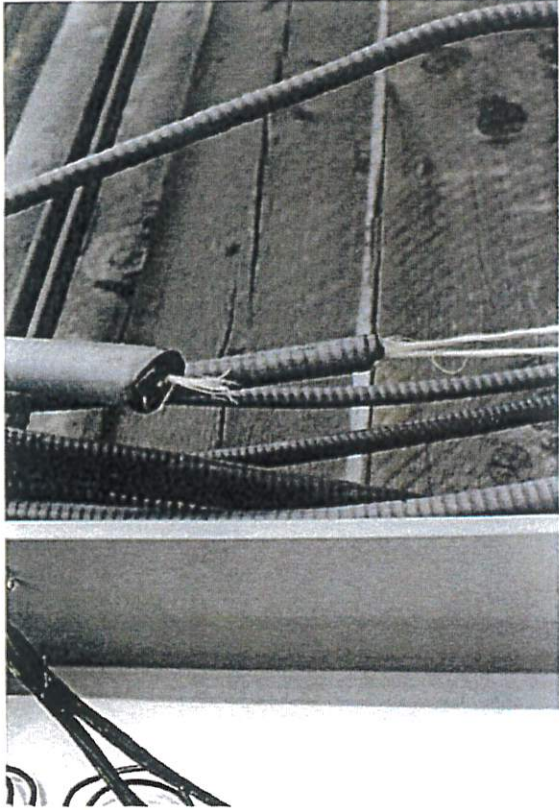
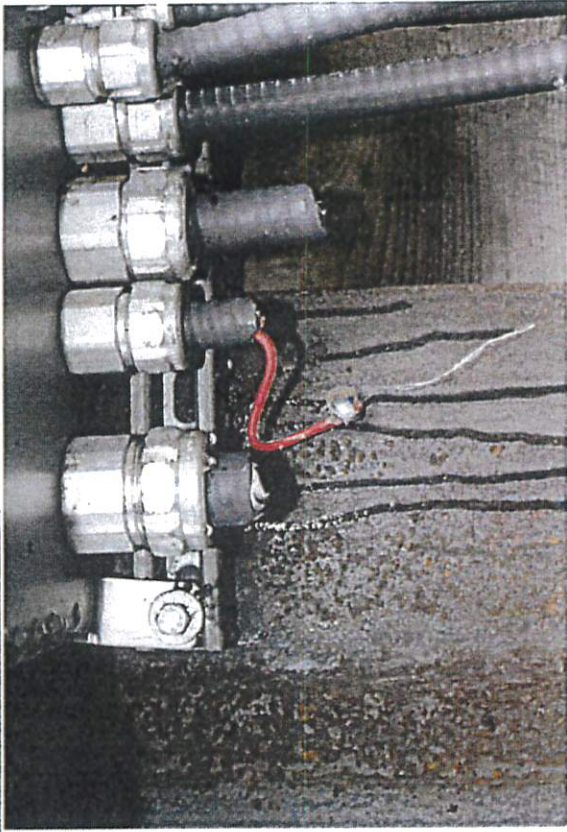
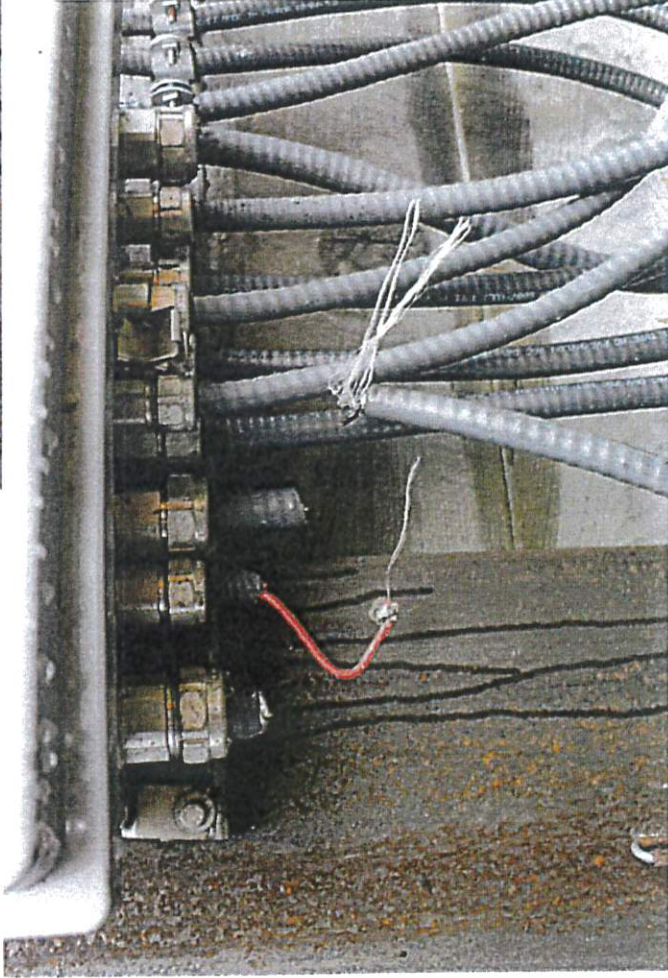
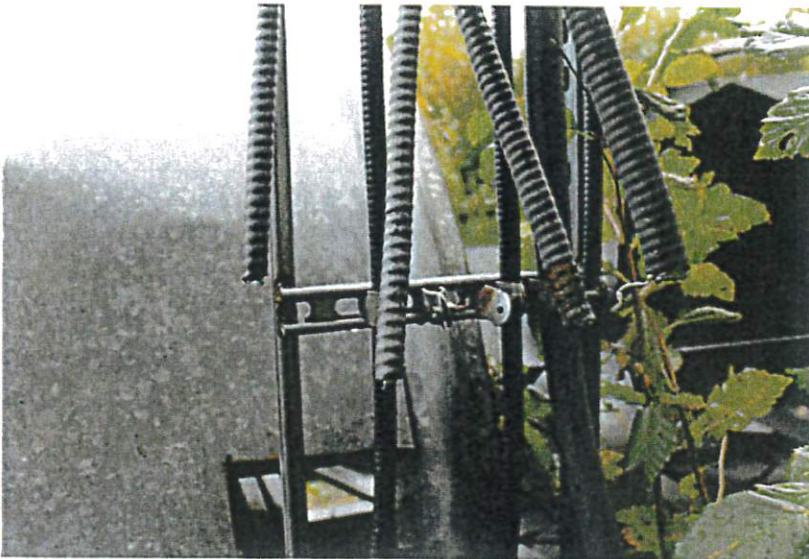
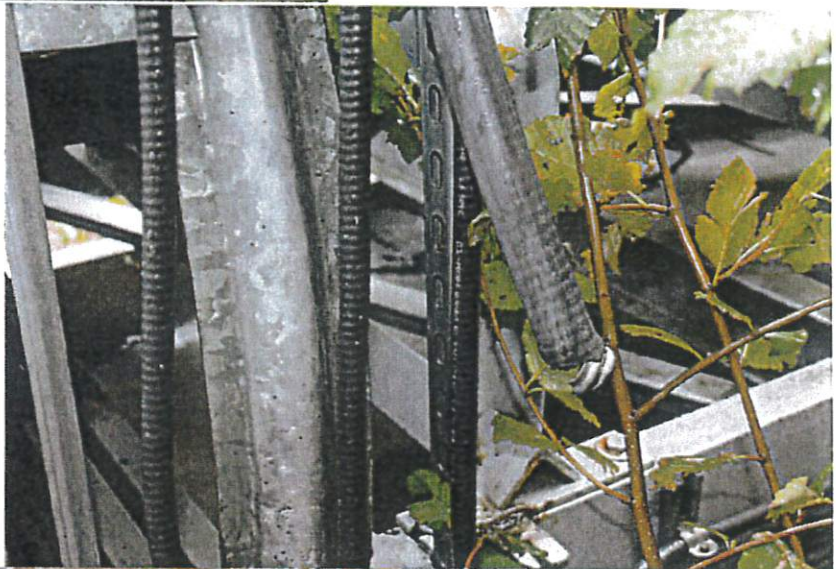
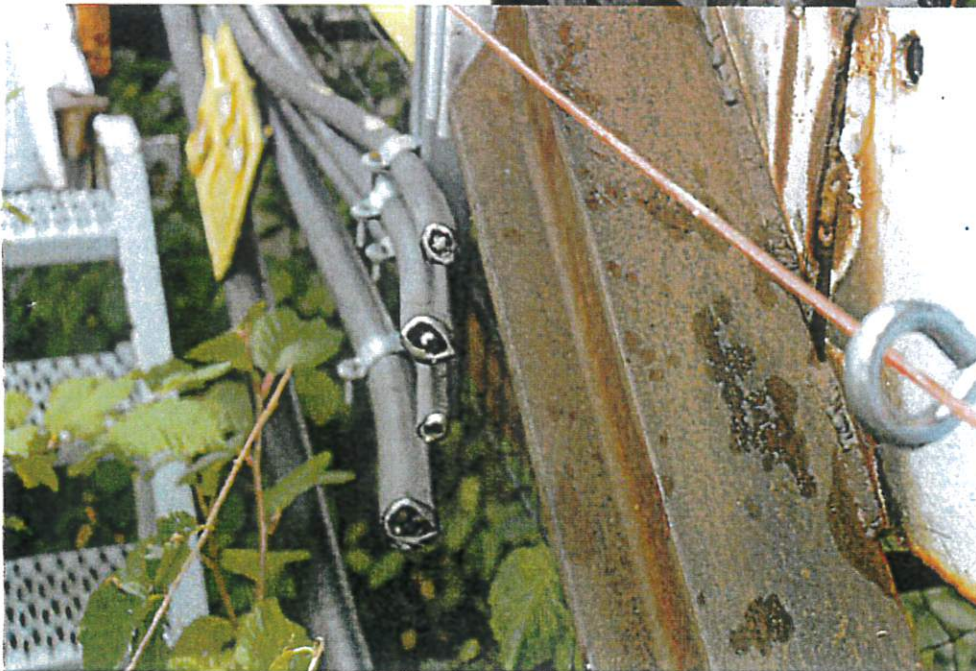
The Reclaim Area is where we noticed the most problems with the system. Tech 90 control cables and power cables were cut and removed from the job site in what looks like a wire theft. Pictures 001 through 006 show the cut cables in different areas. The result will be approximately 300 feet of replacement for most of these cables. A few cables are short and located in the feeder area only.

All Tech 90 cables listed above, would have to be replaced and re-attached to the belt line for the entire distance. Rather than replace cables from the Disc Screen Stairs and walkway back to the Reclaim control trailer, a junction box would be installed, and distribution termination provided for the transition from old cables to new cables.

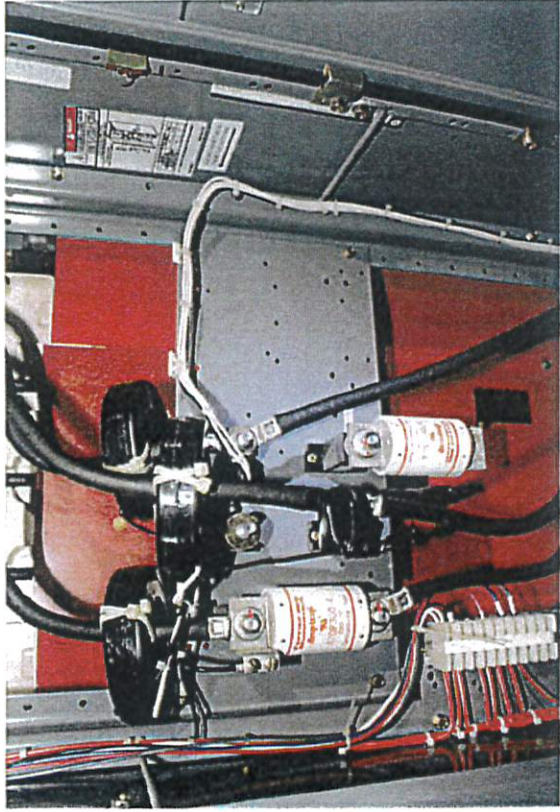
007

- Reclaim Belt #1, has two blown 300-amp fuses. It appears that the fuses were bypassed so that the belt could still be used. These would need to be replaced and put back to original. See photo #007. I don't have an opinion as to why they were blown but the fact that they were bypassed would cause me to assume that it was ran after they bypassed the fuses. Probably in order to finish a loadout.
