**SUBJECT: REPORTING THE CONCLUSION OF THE 2026 LAKE LEVEL ANALYSIS REPORT.**

# **2026 LAKE LEVEL ANALYSIS REPORT**

RESPEC Project Number 10946.26003

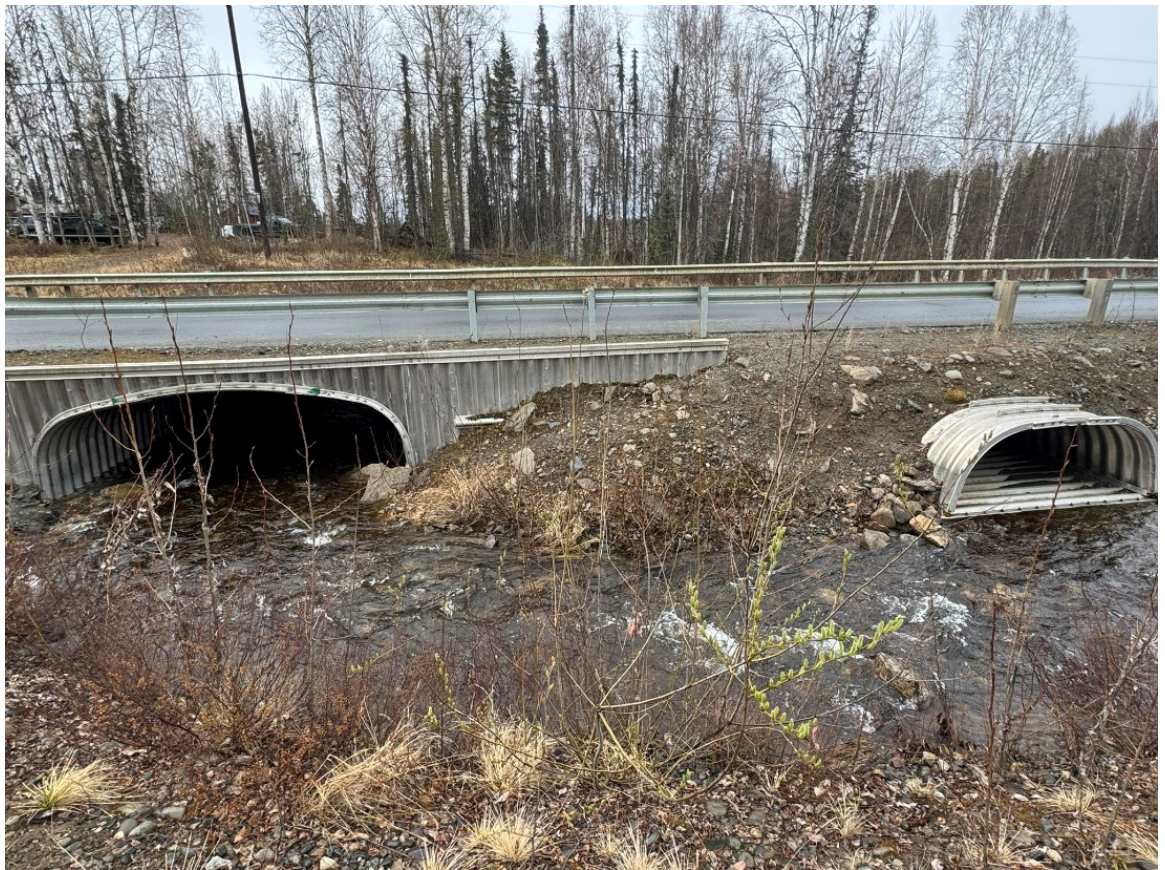
Figure 3-1. Upper Caswell Lake Outlet Culverts

RESPEC team members and a representative of ADNR visited Upper Caswell Lake on May 19, 2026, at approximately 10:30 a.m. Some ice was present on the lake during the site visit, but the area near the outlet was thawed and allowed for good investigation of the outlet structure. Upper Caswell's outlet was identified as a 16-foot, 10-inch span by 8-foot, 3-inch rise aluminum box culvert, with an adjacent 9-foot, 2-inch span by 3-foot, 3-inch rise overflow aluminum box culvert. Both culverts outlet under East Caswell Lakes Road into Caswell Creek and subsequently to Middle Caswell Lake. The culverts are shown in Figure 3-1.

visit photographs with the as-built drawings indicates that the culvert substrate remains largely intact but has been redistributed over time. This movement has resulted in the formation of at least one pool and altered the channel geometry from its original trapezoidal configuration to a more planar profile. Some minor erosion was observed near the inlets and outlets of the culverts. The most evident erosion was near the downstream end the overflow culvert, where the embankment on west side of the culvert had scoured. The observed erosion and scour are minor and will not affect the stability of the culvert and road embankment. The outlet of the spillway channel, connecting to Caswell Creek, was minorly obstructed with branches and rocks.

A high water mark was observed in the primary box culvert and approximately 4 feet, 8 inches below the crown of the pipe.

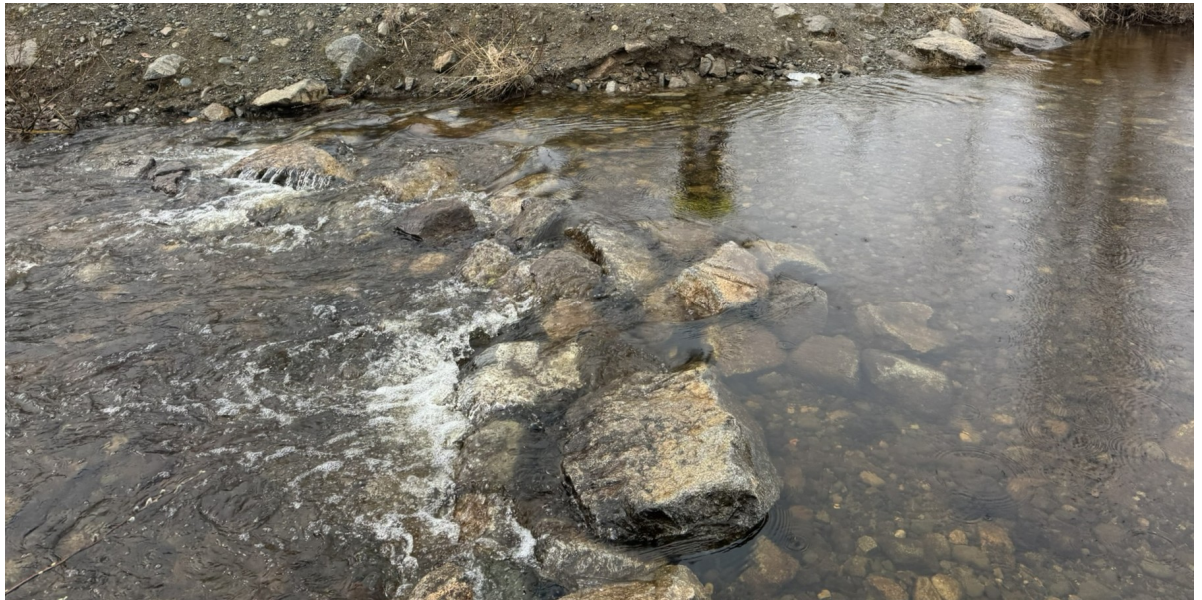
Figure 3-2. Rock Weir at Upper Caswell Lake

The primary control on the lake level is a rock weir located at the upstream end of the spillway channel. Comparison with post-construction photographs indicates that some rocks have been displaced since construction was completed. These changes may have altered the weir crest elevation and could be affecting the lake water level. The weir is shown in Figure 3-2.

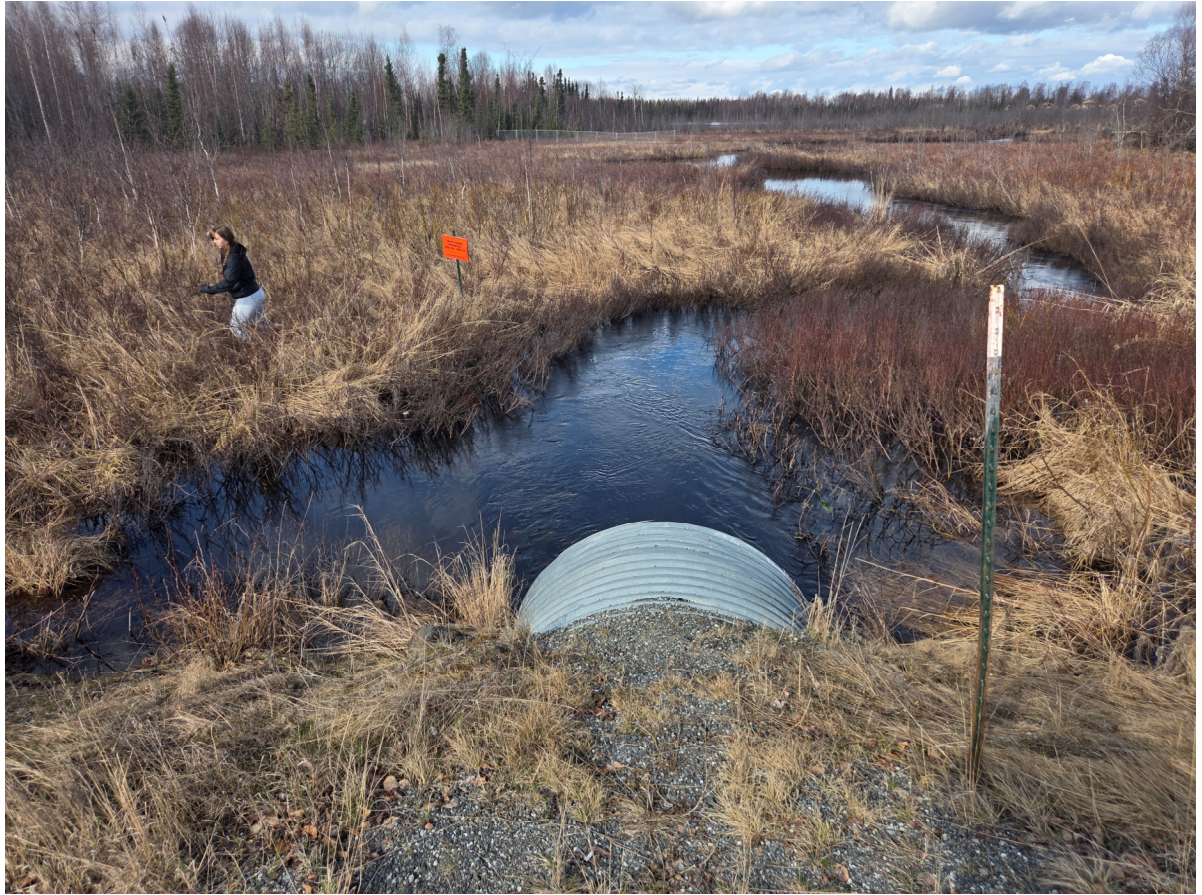
Figure 3-3. Horseshoe Lake Outlet Channel

The project team visited Horseshoe Lake on May 7, 2026, at approximately 10:30 a.m. The lake outlet was identified as a round CMP in good condition. This culvert outlets under South Horseshoe Lake Road into an outlet channel. The outlet channel and culvert are shown in Figure 3-3.

The outlet for this lake appears to be functioning as intended, and the existing culvert is in fair condition. Therefore, no improvements are recommended. To determine the effect that future precipitation would have on the outlet, a hydraulic analysis should be performed using projected future precipitation data.

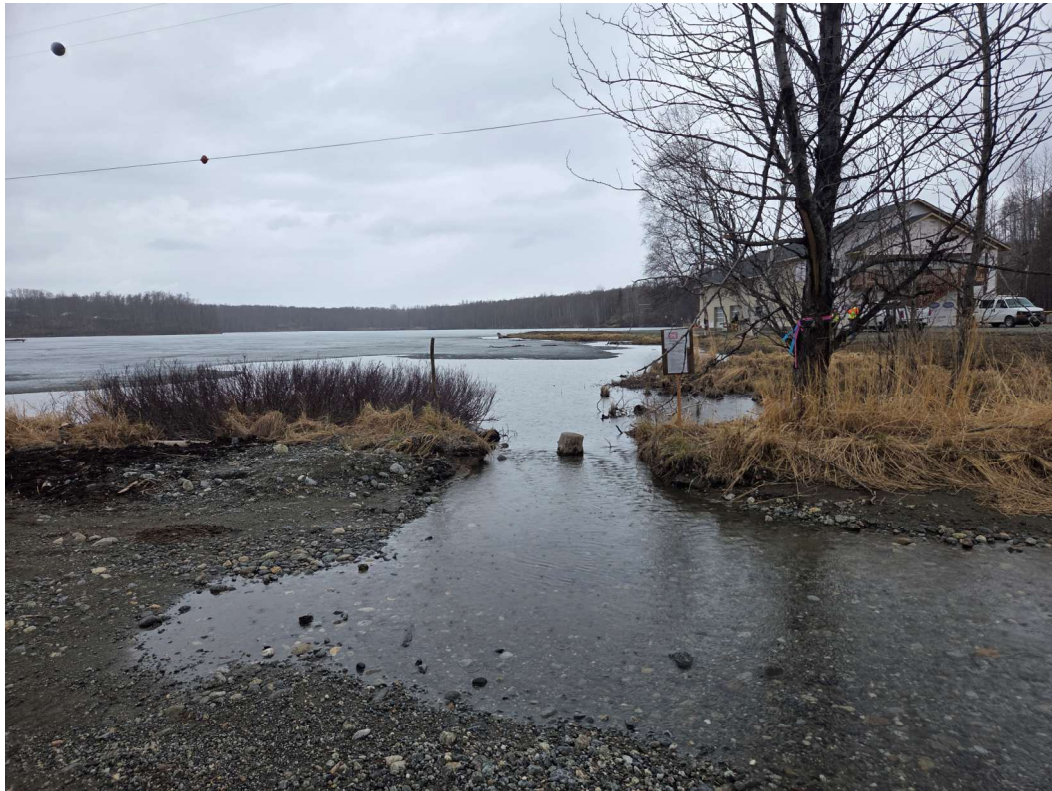
**Figure 3-4.** Knik Lake Outlet Channel – Looking Upstream

The project team visited Knik Lake on May 7, 2026, at approximately 2:25 p.m. Recent construction was observed at the lake outlet, including a newly excavated outlet channel approximately 7 feet wide extending parallel to KGB Road. The channel conveys flow from the lake to an existing 18-inch CMP beneath the Knik Bar & Grill driveway at Northshore Drive. Downstream of the driveway crossing, flow enters a second roadside ditch that continues parallel to KGB Road before crossing beneath KGB Road through an existing 36-inch CMP. The newly excavated channel consists primarily of exposed native gravel and cobble with steep side slopes and little to no established vegetation. No erosion protection, grade control features, or other channel stabilization measures were observed. Minor bank sloughing was evident at several locations, indicating the channel is susceptible to erosion until the banks become stabilized. In addition, the channel was excavated immediately adjacent to the KGB Road embankment, reducing the width of the roadside foreslope and creating steep side slopes between the roadway and the channel. These conditions present roadway safety concerns and may contribute to long-term embankment instability if left unaddressed.

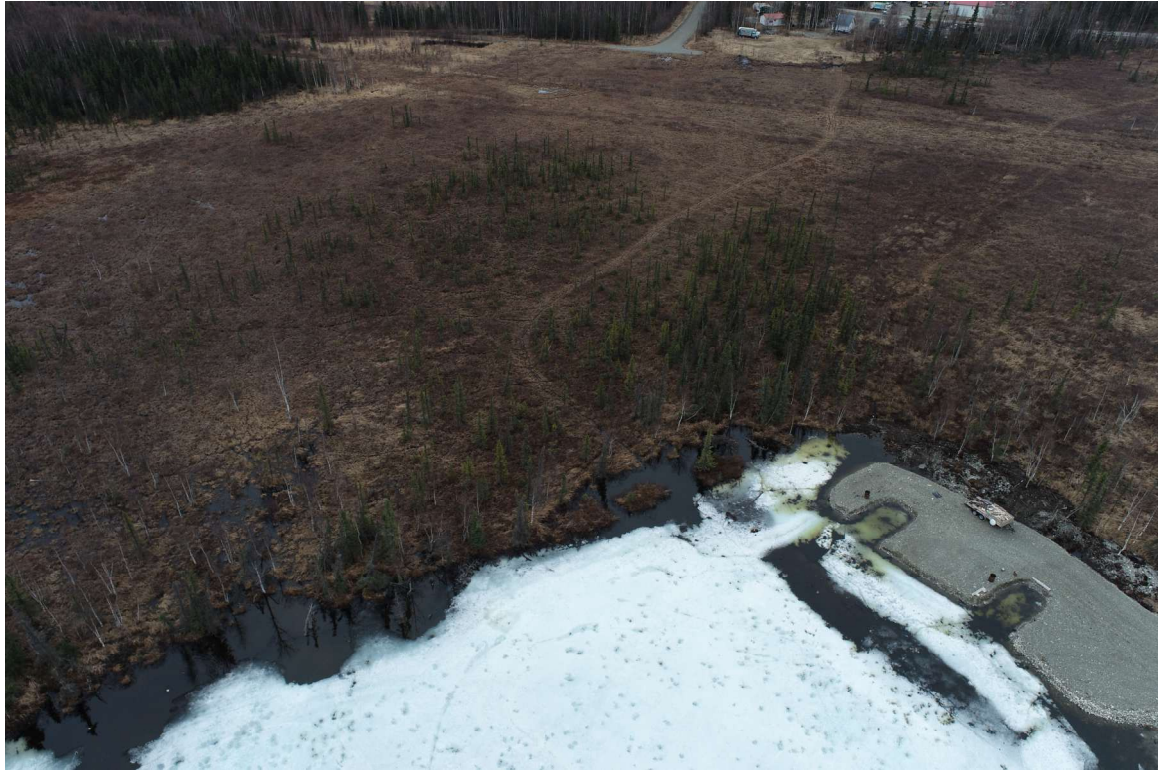
Figure 3-7. Island Lake Outlet Wetland

During the site visit, no defined outlet channel was identified. Instead, surface water from the lake appeared to discharge into an adjacent wetland complex bordering the southern lobe of the lake. Based on field observations, no definitive conclusions could be drawn regarding the potential impacts of recent development on lake levels. Further monitoring and evaluation would be required to better understand the lake's hydrologic response and long-term water level trends.

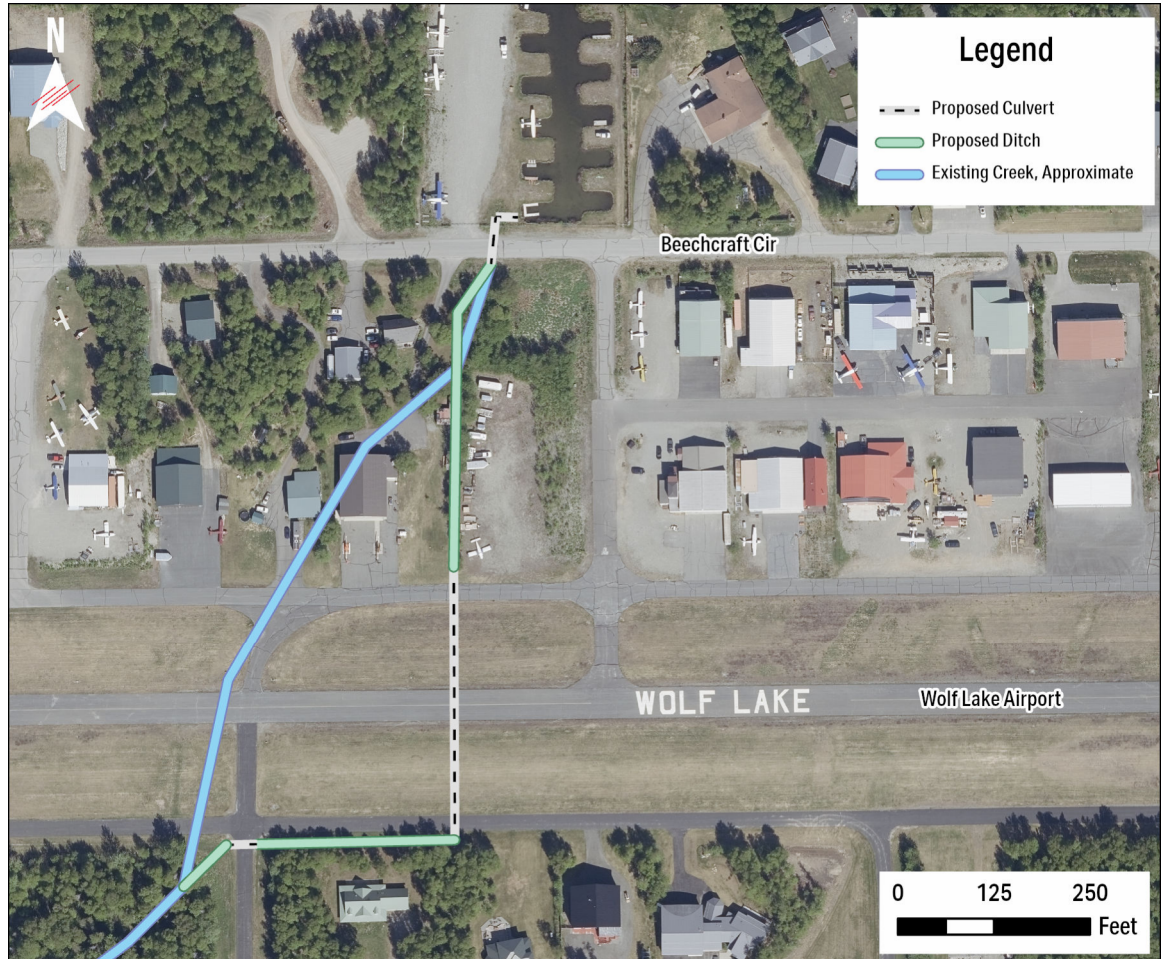
Figure 5-2. Wolf Lake Outlet Configurations

Based on field observations, RESPEC concluded that an excessively long culvert conveys flow from Wolf Lake south to the neighborhood south of the Wolf Lake runway. The culvert is more than 1,000 feet long. Because of the unknown alignment, length, and condition of the existing culvert, RESPEC recommends replacing it with a new piped outlet system that incorporates manholes at intervals not exceeding 300 feet to facilitate maintenance and inspection. The approximate existing outlet configuration, and the new recommended outlet configuration, are depicted Figure 5-2.

Based on a previous report by PND, the existing 24-inch culverts are considered undersized, and a detailed hydraulic analysis is recommended to appropriately size the replacement conduits. For the purposes of this report, a preliminary pipe diameter of 4 feet was assumed to develop a rough order of magnitude construction cost for the proposed system.

A closed conveyance system was selected within the airfield to comply with Runway Safety Area (RSA) requirements, which require that the RSA remain free of hazardous irregularities, including open channels, steep drops, exposed structures, or other features that could compromise aircraft safety.

Because the proposed ditch crosses private property, acquisition of a drainage easement would also be required. In addition, the proposed ditch alignment should be evaluated to verify adequate separation distances from existing private wells and septic systems and to identify any modifications necessary to avoid impacts to these facilities.
