**U.S. Army Corps
of Engineers**
Alaska District

2011 Supplement Background Studies for Expedited Reconnaissance Study of Matanuska River Erosion

Matanuska-Susitna Borough, Alaska

May 2011

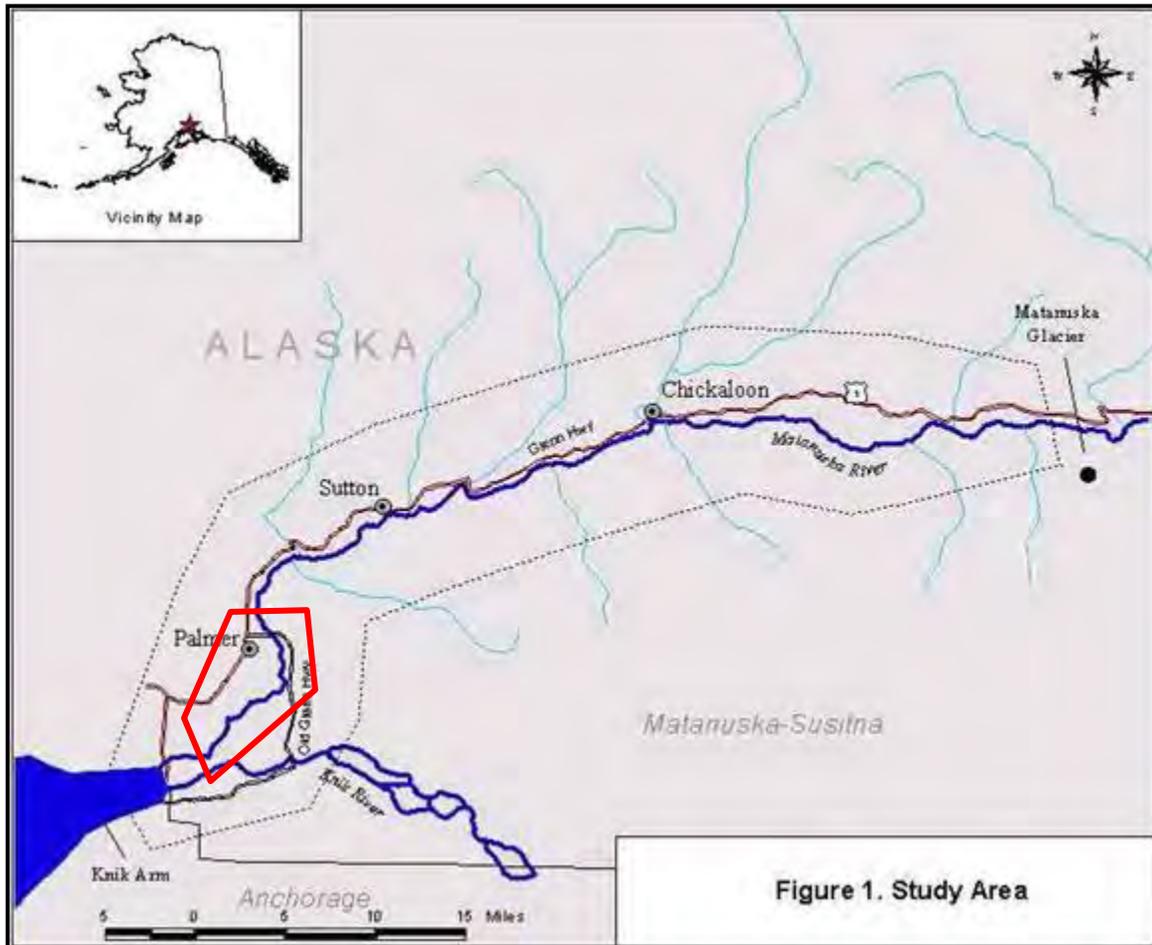
Figure 1. Reconnaissance Study Areas. The 2003 study area is indicated by a dotted black line. The 2011 study area is indicated by a solid red line.

Sutton which were identified as potential sources of erosion problems. This broad study area is identified in Figure 1. This supplement focuses on a more specific study area: The Matanuska River from the Old Glenn Highway Palmer Bridge to its confluence with the Knik River. This area is shown in Figure 2. The study area was reduced for this supplement update as requested by the Matanuska-Susitna Borough.

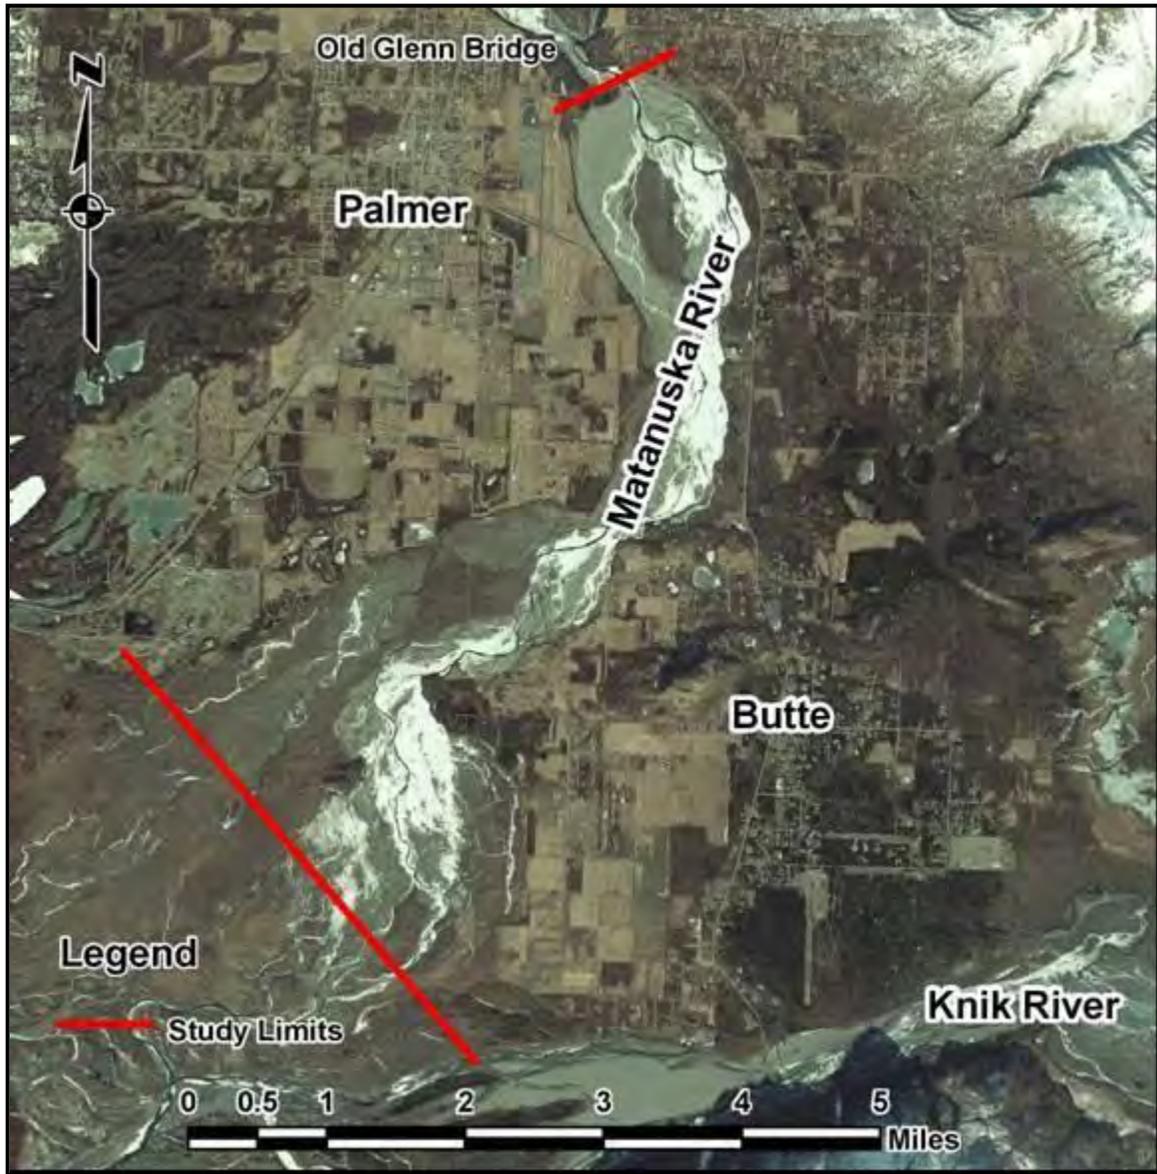
Figure 2. Updated Study Area (May 2011)

Figure 2 shows the study area for this supplement, while Figure 4 and Figure 5 illustrate the areas identified to be at risk of erosion over the 50-year project period of analysis.

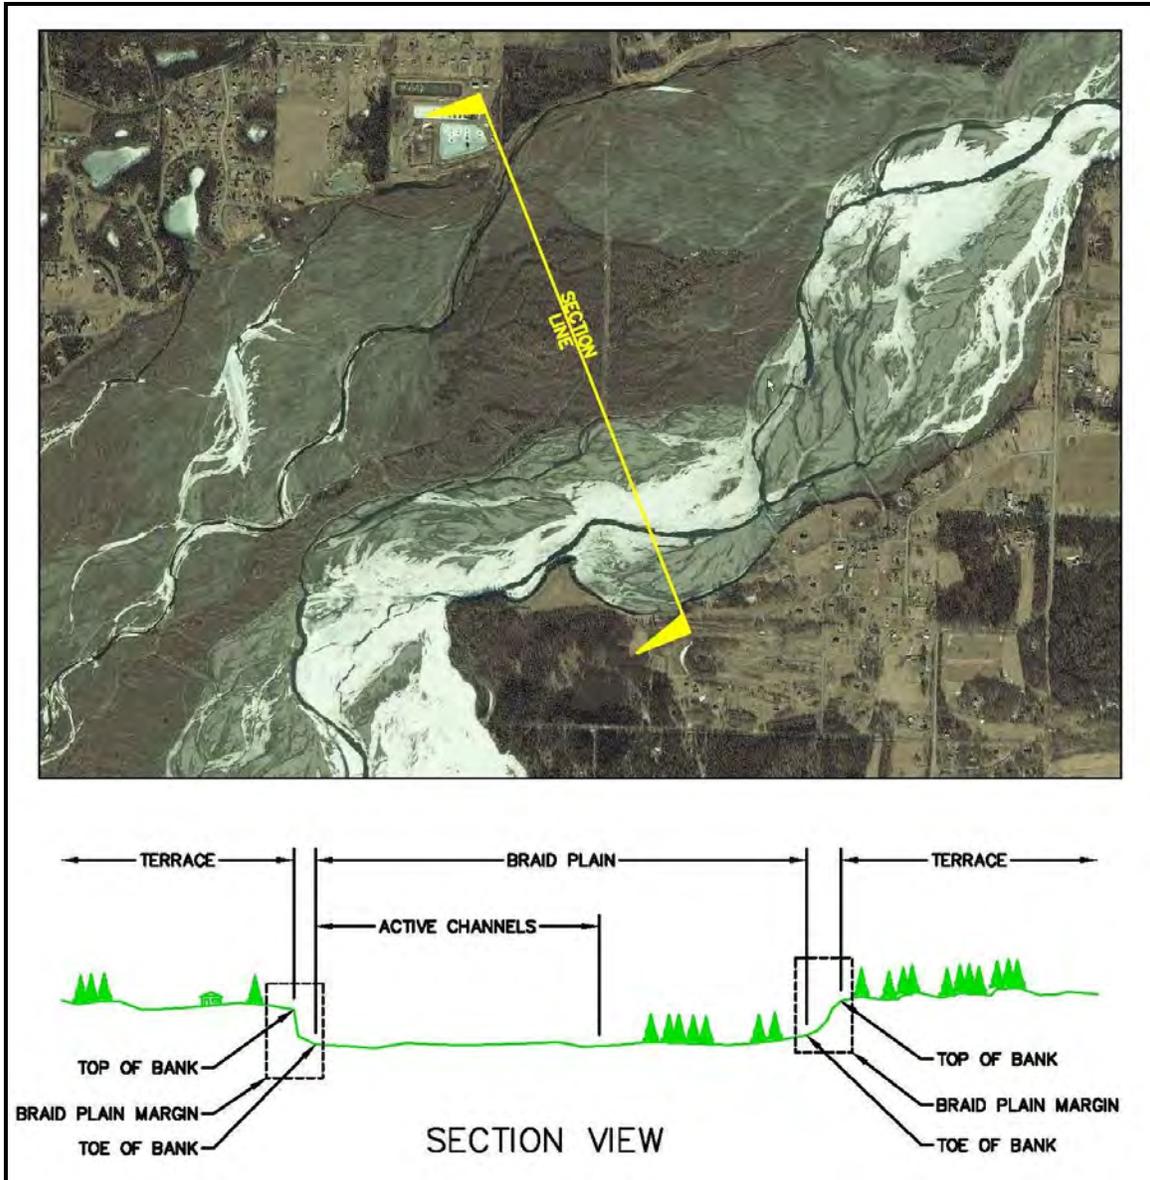
Figure 3: Braid plain definition schematic. Note that the section view does not represent survey data on the Matanuska River.

The unpredictability of the locations of individual channels within the braid plain makes it difficult to predict future erosion trends in the river. Conventional methods for predicting rates of erosion rely on a historical progression of bank lines. Typically, the distance between these bank lines is divided by the number of years between data sets to produce an average rate of erosion. On single channel sinuous rivers, this rate can be reasonably projected into the future to estimate the location of the banks in future years. In braided rivers, the same process occurs within the braid plain; however multiple channels interact in unpredictable ways, either converging or cutting off flow to produce rapid and dramatic changes in location of the individual channels. While erosion in the river is a continuous process, it only has noticeable impact when a channel in the braid plain erodes the bank at the braid plain margin. For purposes of erosion monitoring, the top of bank at the braid plain margin is used to define a bank line for any given year.

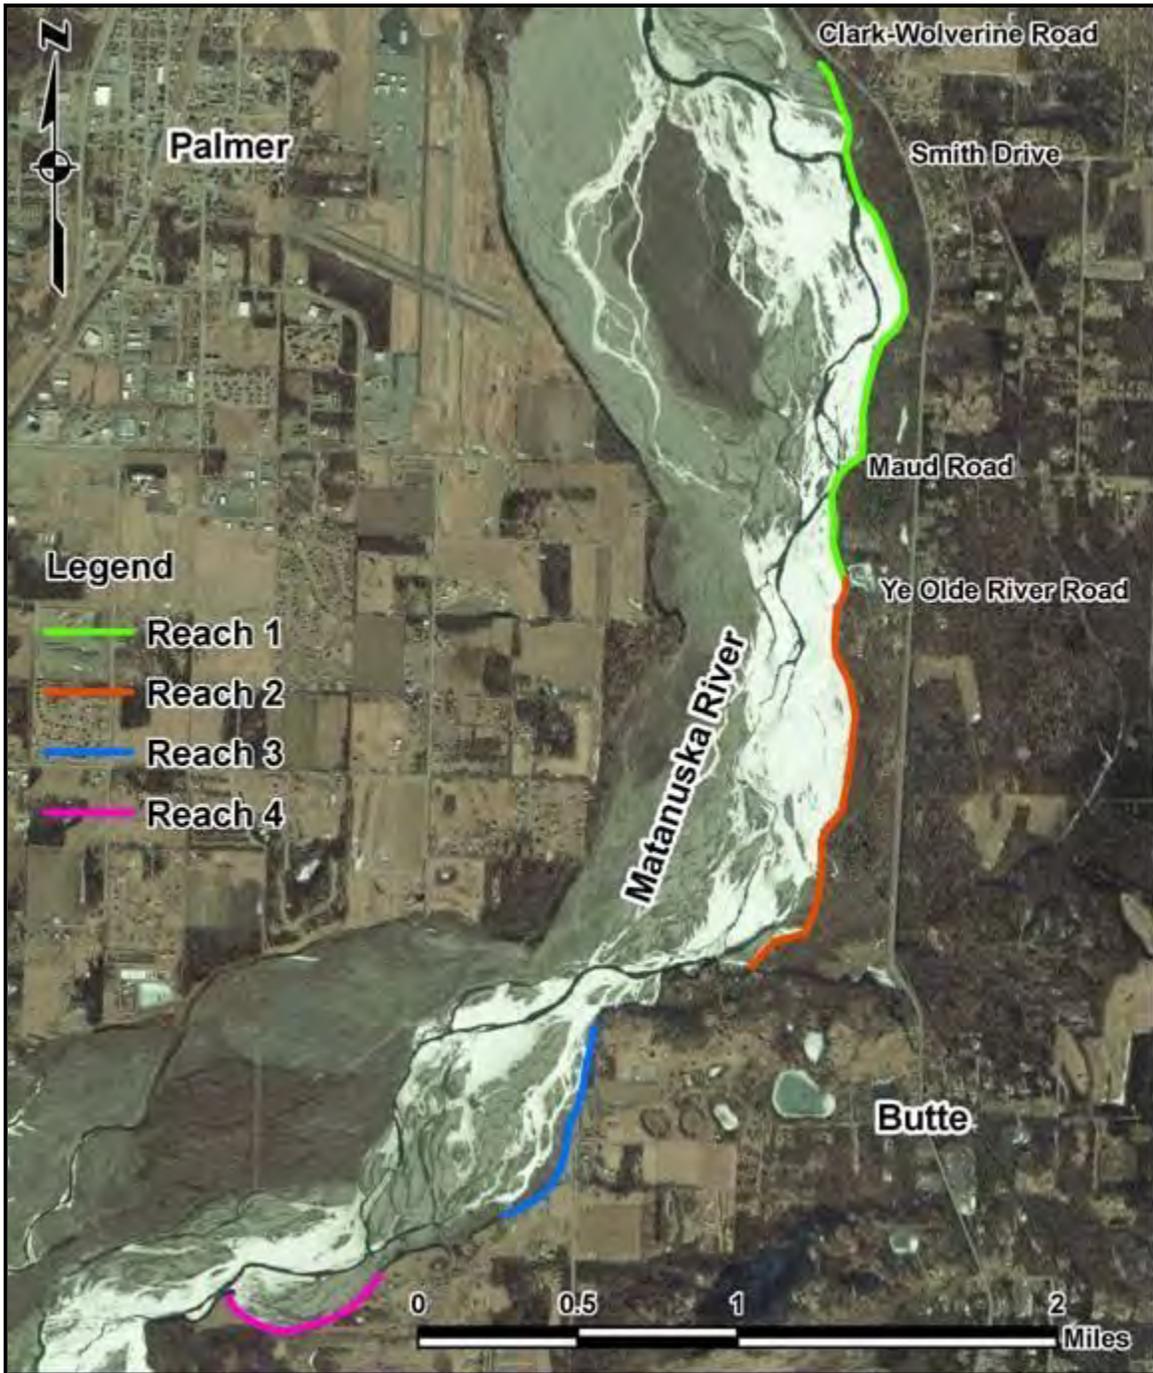
Figure 4. Erosion Reaches in the study area

Areas of the left bank that show significant erosion over the period of record were divided into four reaches (see Figure 4) for further analysis. Reach 1 begins near Clark-Wolverine Road and ends near Ye Olde River Road. Reach 2 begins at Ye Olde River Road and continues to a sharp westward bend in the braid plain margin. This bend is likely caused by hard material at the braid plain margin. Reach 3 begins near Man-O-War Road and ends at the upstream extent of the riprap dikes near Circle View Estates. Reach 4 begins at the downstream extent of the same dikes and extends to a hard point downstream of Circle View Estates. The hard points mentioned showed no discernible erosion over the period of record. All of these reaches are on the left bank of the river.

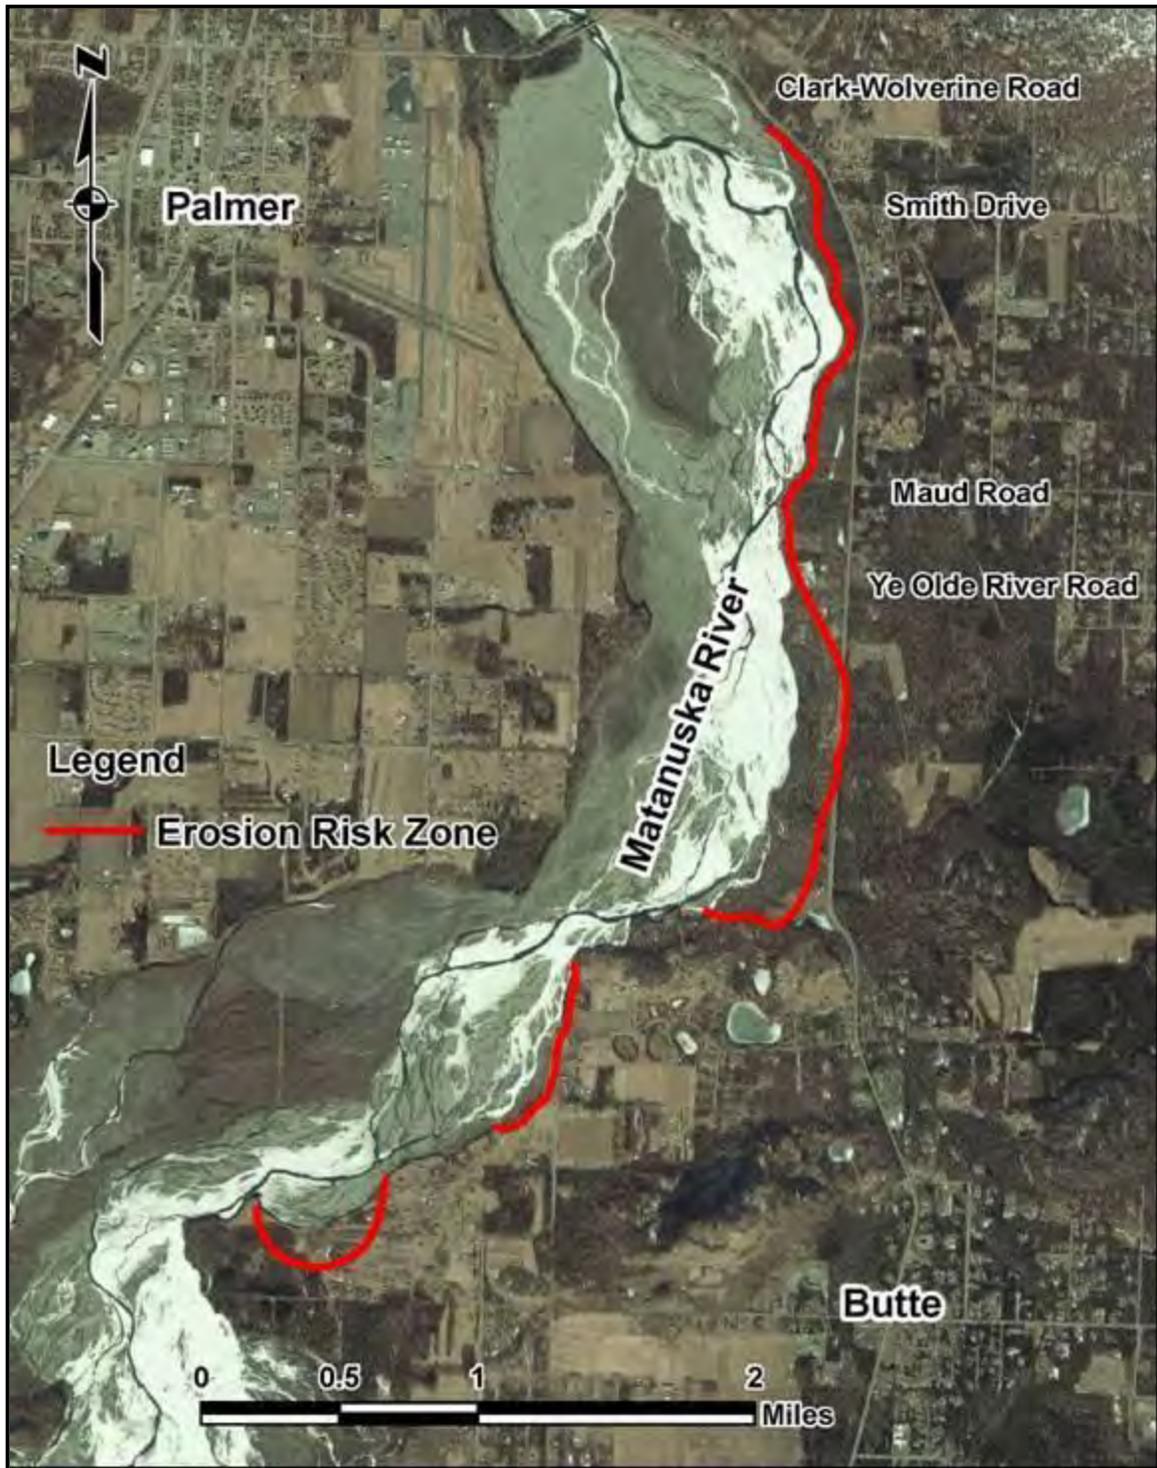
Figure 5. Erosion Risk Zones

115 feet from the 1990 bank line near the northwest corner of Bodenburg Loop. A buffer of 165 feet and 115 feet respectively was offset from the 2007 bank line for these reaches to account for the severity of episodic events in these areas. These buffers are not extrapolations to a specific future date since it is possible for multiple events to occur at the same location over any given period.

Persistent erosion was found in Reach 2 and Reach 4. In these reaches, the frequency of erosion events created a continuous progression of bank loss over the period of record. Erosion on these reaches was calculated in a traditional manner as if the eroding banks were the outside banks in the bend of a sinuous river. Along both reaches, the maximum average rate was estimated to be 17 feet per year. This rate was used to offset the 2007 bank line to project likely erosion in the future, however, since erosion in these reaches is episodic, the yearly rates of erosion may vary greatly from the average making short term predictions of erosion very unreliable. To account for this uncertainty, a 50 year offset at the average rate was created with the ends of the reaches tapering to meet adjacent risk zones or hard points along the bank.
