SUBJECT: INFORMING THE ASSEMBLY OF THE COMPLETED PLANNING ASSISTANCE FOR STATES (PAS) TECHNICAL REPORT FOR TALKEETNA EROSION ASSESSMENT DECEMBER 2023 BY THE USACE

Planning Assistance to States
Technical Report

Talkeetna Erosion Assessment Technical Assistance

Talkeetna, Alaska

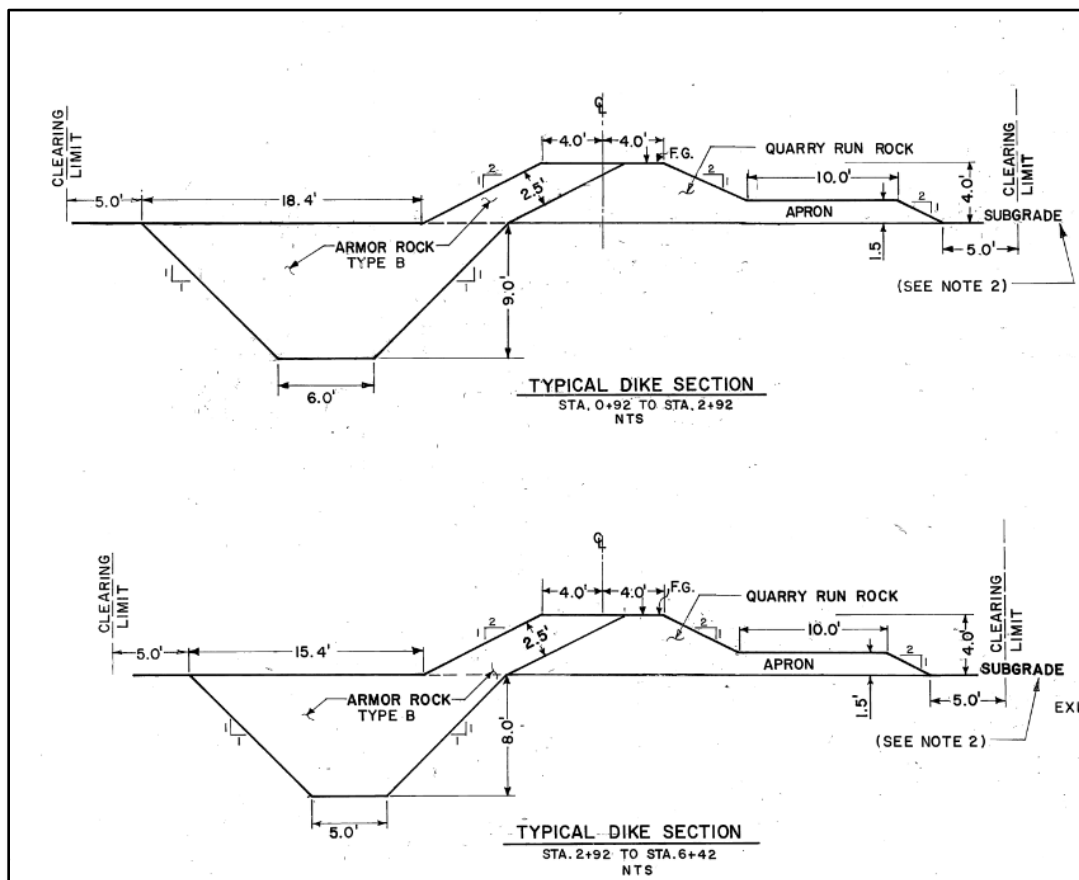
Figure 6. Typical dike cross section information.

The dike consists of a buried toe, raised berm, and a landward apron. The designed crest width is 8 feet wide and has an elevation of 4 feet above the ground surface (Figure 6).

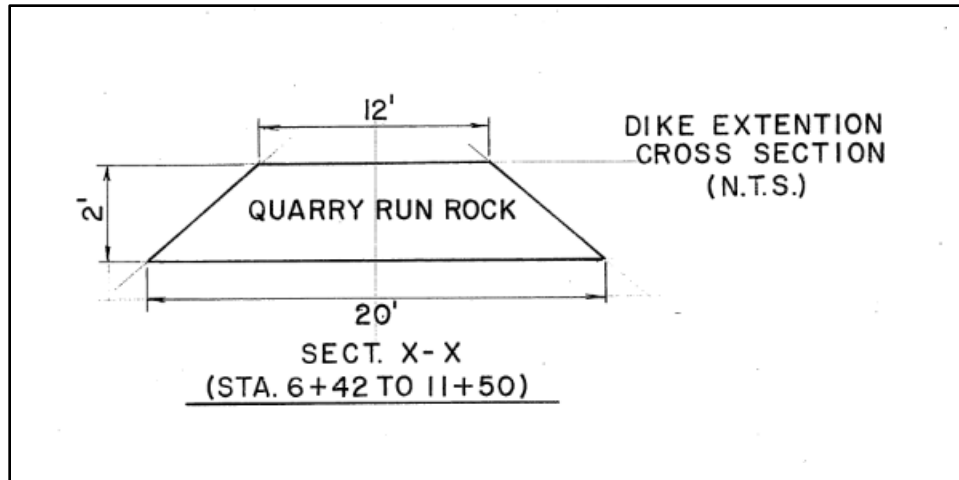
Figure 7. Typical cross section for dike extension from 1979 As Built.

The dike extension consists of a raised berm 2 feet above the ground surface with a designed crest width of 12 feet. The dike extension was not designed or built with any toe rock protection or landward apron (Figure 7).

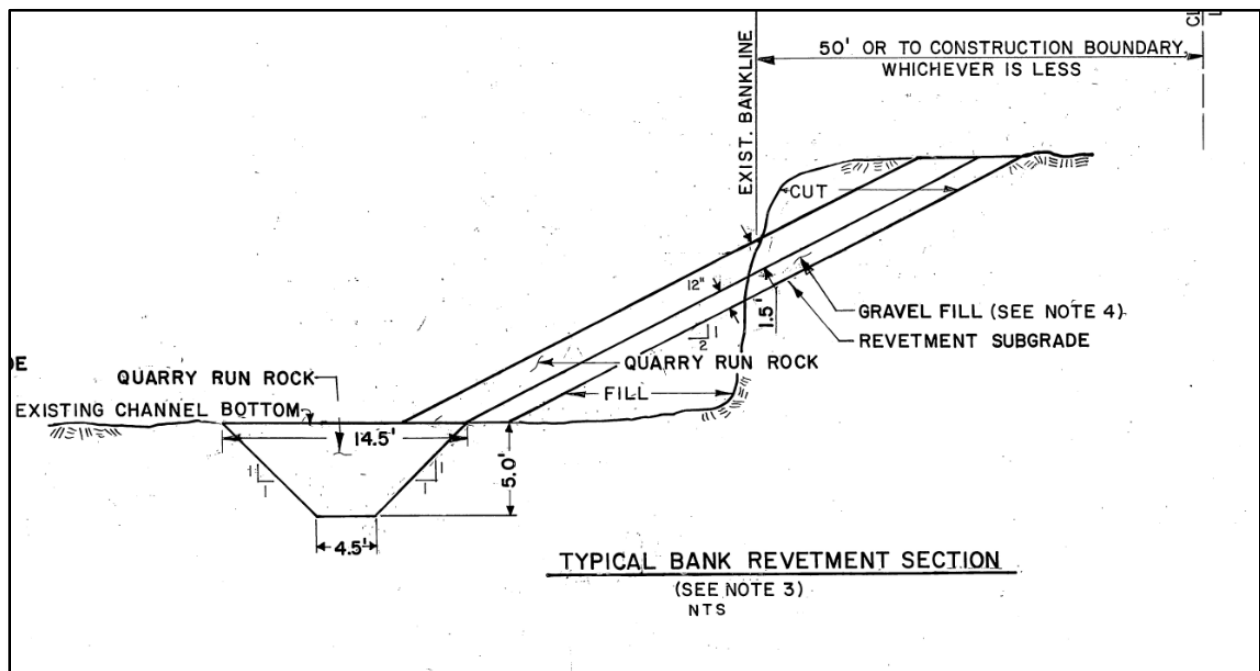
Figure 8. Typical cross section for revetment from 1979 As Built.

The revetment consists of a buried toe with quarry run rock over gravel fill (Figure 8).

These structures have experienced significant erosion since they were built (Figures 9-11), with most of the erosion occurring after the 2012 flood when the main stem of the Susitna River shifted to flow against the east bank. An engineered design repair was needed on the dike extension after the 2012 flood and was completed by FEMA in 2017. Emergency repairs were needed due to severe erosion along the dike extension and revetment in 2020 and was performed by the Matanuska-Susitna Borough (Figure 12). Severe erosion is occurring at the confluence of the Talkeetna River and Susitna River after the dike extension (Figure 13), where a large and deep eddy has formed since 2017 which was measured to be up to 40 feet during the summer.

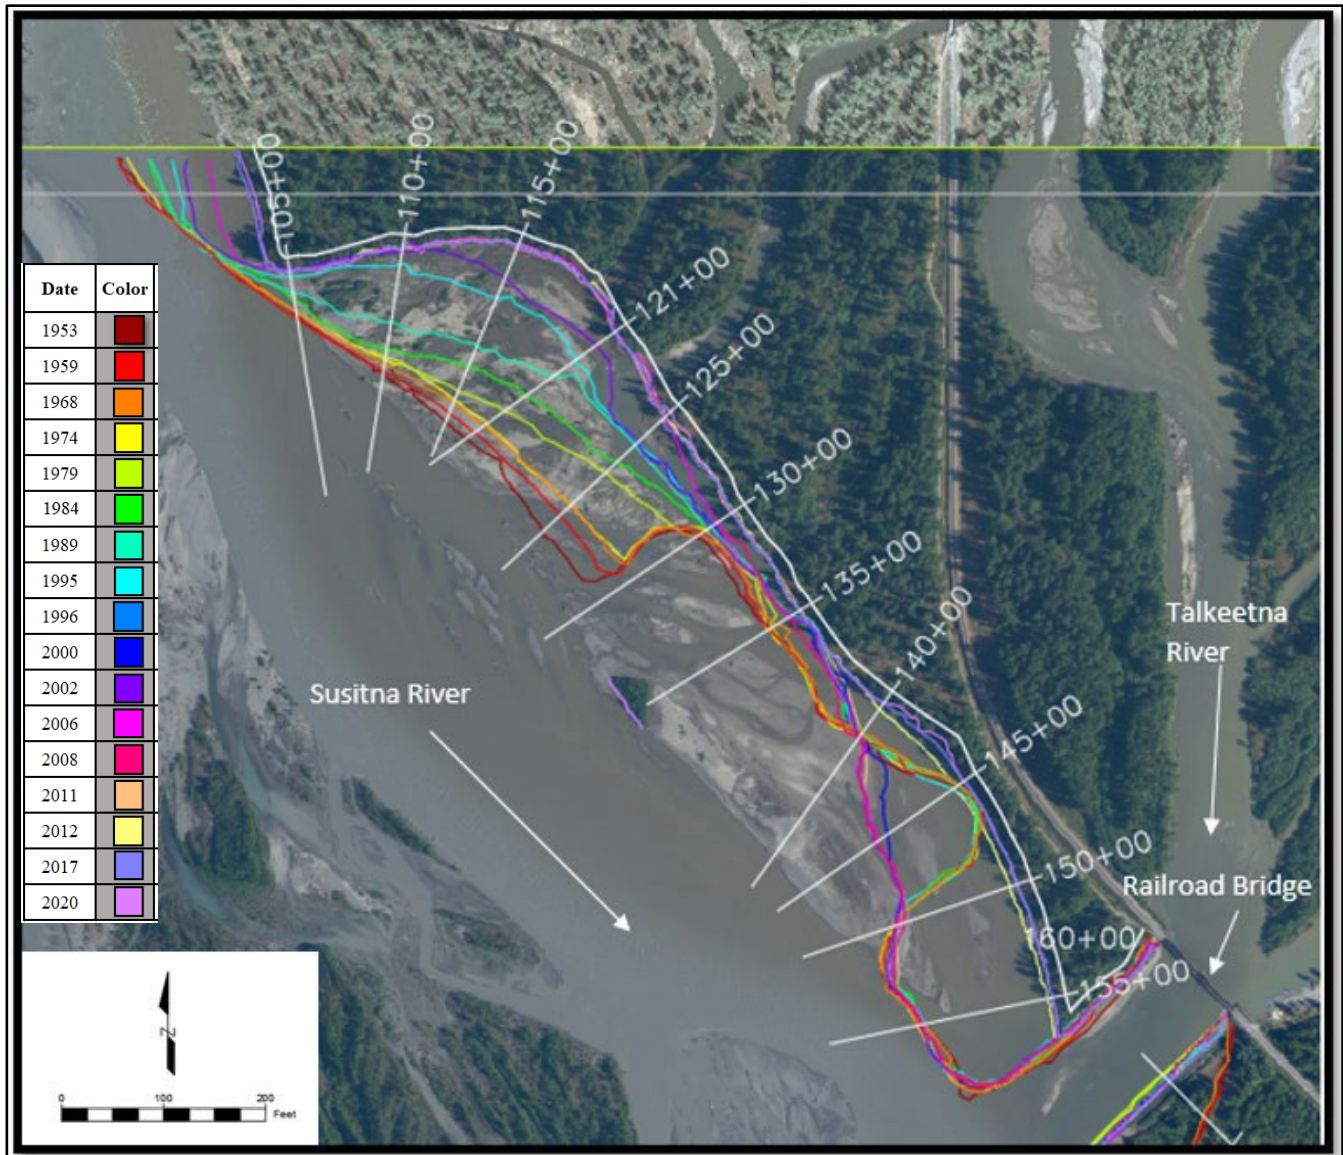
Figure 19. Overview of traced bank-lines, North Region (Google Earth Imagery, 2020).

Table 2. Erosion rates between years on record (units of feet/year) for North Region.

Station	2017-2020	2012-2017	2011-2012	2008-2011	2006-2008	2002-2006	2000-2002	1995-2000	1989-1995	1984-1989	1979-1984	1974-1979	1968-1974	1959-1968	1953-1959
105+00	-4.1			-17.6					11.0	6.2			0.1	3.3	-2.6
110+00	-1.9	-0.9	7.4	-20.7					40.6	22.5	6.6	2.2	3.6	2.9	1.3
115+00	-5.0	-1.0	7.8	-18.1					35.3	18.7	21.8	8.2	2.5	5.1	6.3
120+00	1.5	-0.8	3.0	-27.5					19.6	26.8	22.7	17.8	3.2	5.2	7.0
125+00	10.6	-0.3	3.8	-26.3			-0.7	-0.1	2.9	21.1	12.2	39.4	0.7	6.5	16.6
130+00	-5.0	0.0	12.2	-20.2			-10.7	2.8	1.6	0.4	3.0	-0.9	7.1	-2.0	4.3
135+00	-1.9	0.0	-1.2	19.1	-4.9	-0.1	-1.6	-0.7	0.2	0.4	19.5	3.5	-6.4	3.6	-1.1
140+00	1.6	5.7	126.3	6.4	-0.6	-1.0	-3.5	2.1	-2.1	-0.4	1.0	0.6	-1.7	1.0	1.6
145+00	-0.4	9.9	394.8	-1.6	0.5	2.4	-32.0	-65.6	-4.9	1.1	-1.3	2.6	-2.3	1.8	-0.7
150+00	1.0	5.4	489.0	-7.7	12.4	3.7	-1.0	-2.3	1.0	-1.0	3.5	2.3	-1.0	-1.4	1.0
155+00	-0.8	3.3	529.6	3.8	-5.2	2.6	-5.9	-1.1	0.7	-0.3	3.0	2.4	-4.5	2.2	-3.7

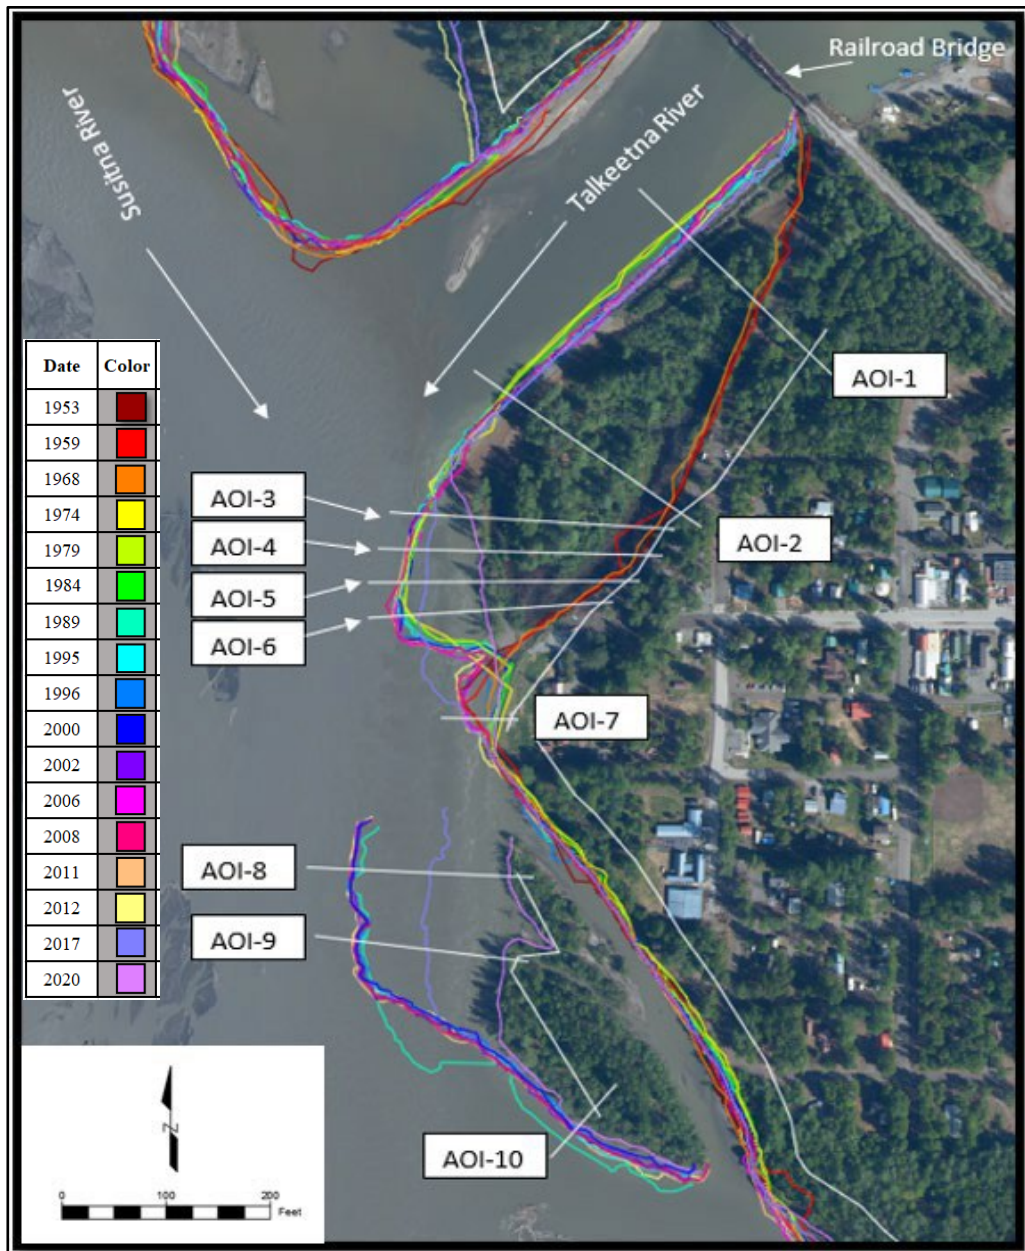
Figure 20. Overview of traced bank-lines, Area AOI (Google Earth Imagery, 2020).

Table 3. Erosion rate between years on record (units of feet/year) for Area AOI.

Station	2017-2020	2012-2017	2011-2012	2008-2011	2006-2008	2002-2006	2000-2002	1996-2000	1995-1996	1989-1995	1984-1989	1979-1984	1974-1979	1968-1974	1959-1968	1953-1959
AOI-1	0.5	0.9	8.7	-0.7	-1.0	1.2	0.4	1.2	-4.2	0.7	3.3	1.1	-0.7	-39.6	-1.8	0.2
AOI-2	-0.8	1.9	-3.8	1.3	-1.4	-0.7	1.1			-0.2	2.9	0.2	-1.1	-73.5	0.1	-1.4
AOI-3	25.5	4.9	3.3	0.0	-4.4	4.1	-2.1			1.5	-3.0	0.2	0.4	-83.9	5.2	-10.2
AOI-4	38.9	5.8	18.1	-0.7	-9.2	3.2	-1.4			0.0	-0.8	1.3	0.4	-81.9	4.1	-9.5
AOI-5	41.3	10.0	10.3	-0.8	-3.4	-0.5	-3.1			0.4	-2.0	1.9	-1.7	-71.6	-0.7	1.1
AOI-6	48.4	12.2	-2.3	0.7	-2.7	-2.5	-4.2			-1.8	-0.6	-0.7	-0.8	-58.9	0.0	-1.9
AOI-7	23.1	0.3	1.7	-0.1	-2.2	0.3	-28.9	2.1	-8.1	-1.1	-0.6	1.2	-3.7	5.0	2.8	0.7
AOI-8	58.1	33.9	3.5	-0.2	-2.7	0.5	-1.7	-1.6	1.5	-2.5						
AOI-9	56.6	32.3	1.1	-1.5	-2.0	-0.2	-0.9	-1.4	-2.4	-0.7						
AOI-10	5.1	-0.4	6.0	-0.4	1.2	0.3	-3.4	-1.3	10.4	5.0

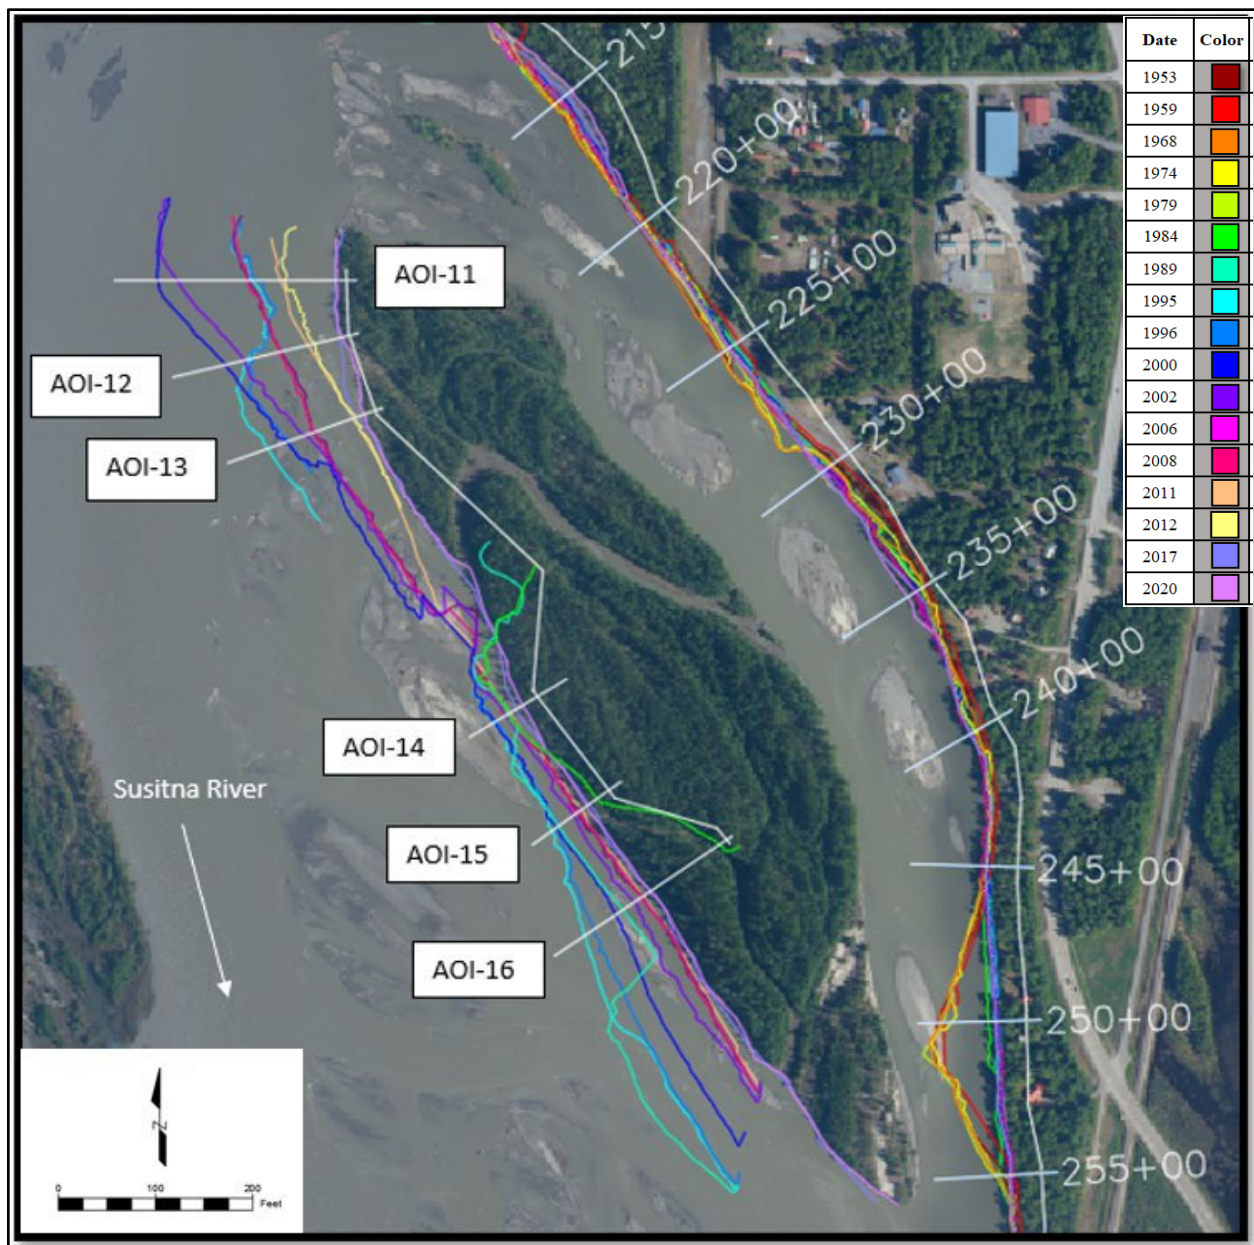
Figure 21. Overview of traced bank-lines, Area AOI, continued (Google Earth Imagery, 2020).

Table 4. Erosion rate between years on record (units of feet/year) for Area AOI, continued.

Station	2017-2020	2012-2017	2011-2012	2008-2011	2006-2008	2002-2006	2000-2002	1996-2000	1995-1996	1989-1995	1984-1989	1979-1984	1974-1979	1968-1974	1959-1968	1953-1959
AOI-11	-0.4	32.9	15.5	35.7	-2.3	57.9	32.4	-81.4	19.7							
AOI-12	2.5	16.6	22.1	30.9	-1.3	30.8	31.3	-22.5	7.1							
AOI-13	9.5	0.8	6.3	44.0	0.1	7.9	32.1	-1.0	70.4							
AOI-14	8.2			5.9	-3.6	1.3	20.1	-0.6	7.4	-8.9	0.6					
AOI-15	-2.7			4.8	-6.2	7.4	33.6	0.4	18.3	-4.4	-31.0					
AOI-16	1.6			2.6	-2.0	7.8	36.5	21.9	32.2	-24.7	-75.3

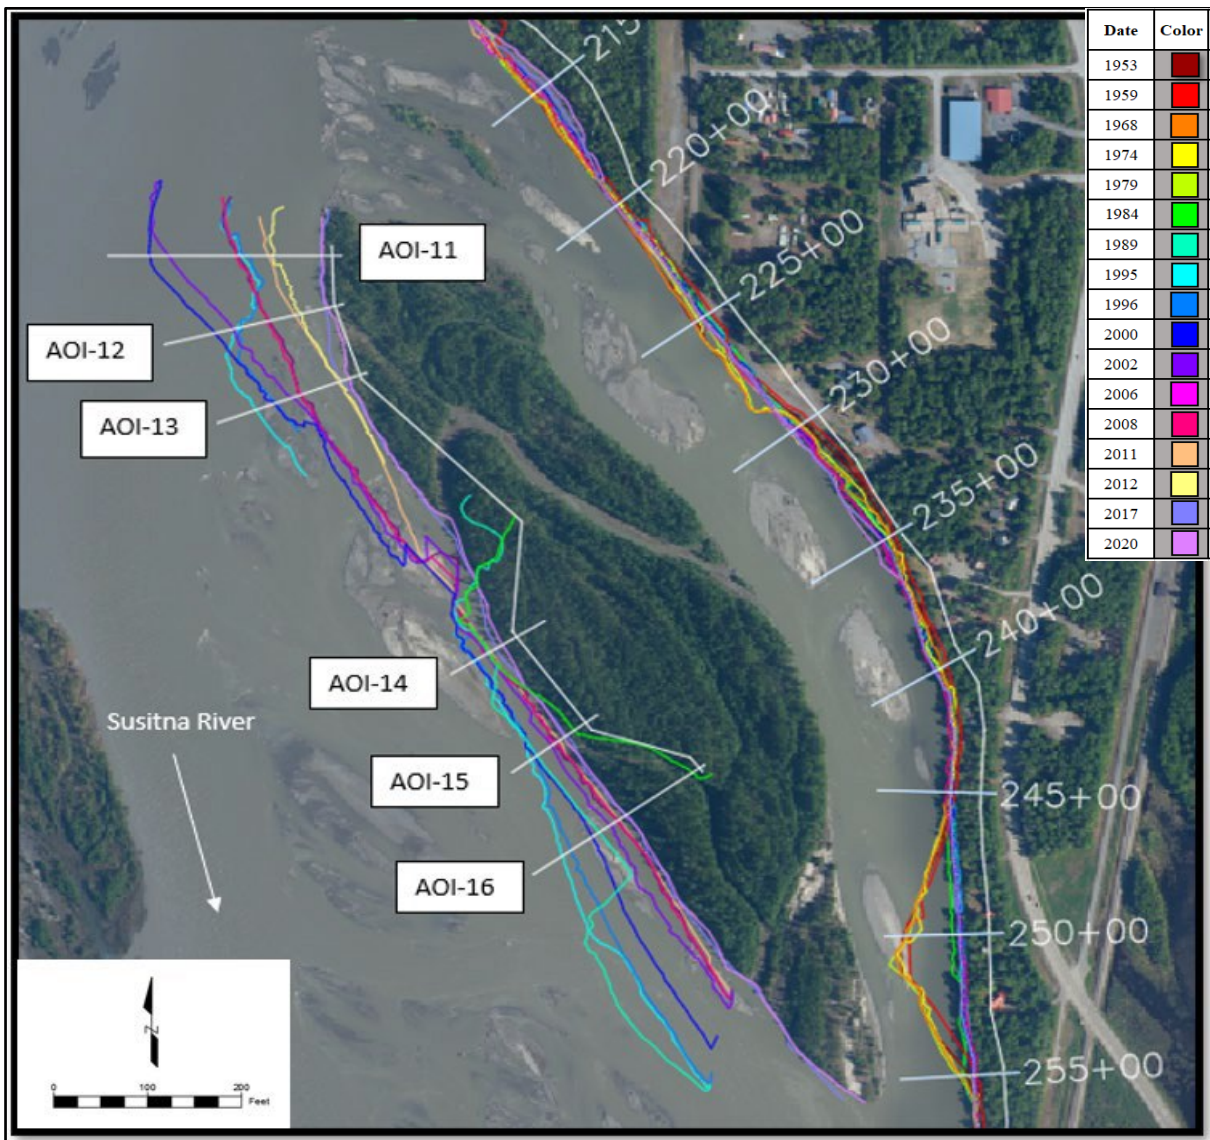
Figure 22. Overview of traced bank-lines, Area CHNL (Google Earth Imagery, 2020).

Table 5. Erosion rate between years on record (units of feet/year) for Area CHNL.

Station	2017- 2020	2012- 2017	2011- 2012	2008- 2011	2006- 2008	2002- 2006	2000- 2002	1996- 2000	1995- 1996	1989- 1995	1984- 1989
CHNL-1	-1.3	3.1	-15.9	-2.4	0.0	2.4	-58.9	-52.7	-3.8		
CHNL-2	1.3	-14.8	14.4	-0.7	-23.9	8.3	-64.8				
CHNL-3	-0.7	-4.9	-0.9	-0.4	-1.7	-8.4	-71.4				
CHNL-4	-0.7	2.9	-5.2	-1.1	-2.7	-1.7	-2.2	-68.2	-1.5	-18.7	-0.7
CHNL-5	0.4	7.2	-21.2	1.8	-3.5	-4.2	-3.9	-61.8	4.2	-26.3	1.4
CHNL-6	-1.1			0.8	-1.5	-6.9	-1.1	-76.1	105.0	-33.3	-5.2
CHNL-7	-3.7			-4.6	9.5	-1.7	-3.4	-66.4	4.7	-2.4	-24.6
CHNL-8	2.0			-0.6	1.0	-0.7	-0.1	-74.4	12.9	-3.6	-18.1
CHNL-9	0.0			0.4	2.7	-5.1	1.4	-76.9	2.7	-2.0	-8.2
