Background Studies for Expedited Reconnaissance Study of Matanuska River Erosion

Matanuska-Susitna Borough, Alaska

August 2003

**Tetra Tech, Inc., Infrastructure Group
1925 Post Alley
Seattle WA 98125**

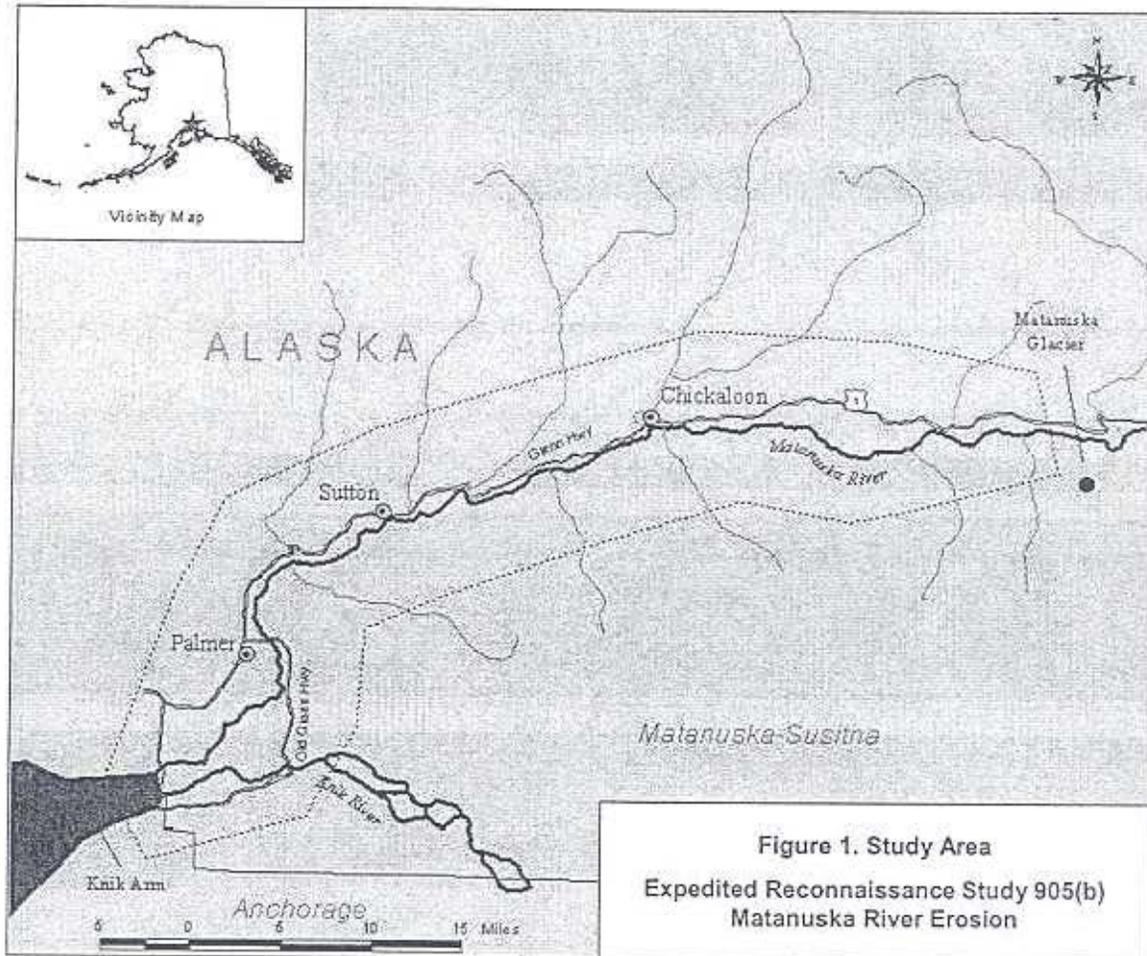
The Matanuska River flows from the Matanuska Glacier approximately 50 miles upstream of the Old Glenn Highway Bridge in Palmer, Alaska to its confluence with the Knik River approximately 10 miles downstream of the same bridge (Note: The East and South Forks extend an additional 20 miles past the Matanuska Glacier.). Downstream of the confluence the Knik River flows into the Knik Arm of Cook Inlet. For this reconnaissance study of erosion issues in the Matanuska River Valley, the initial study area included the river valley from the confluence with the Knik River upstream to the glacier. After an initial appraisal of erosion issues in the basin, the areas in the vicinity of Palmer and Sutton were identified as potential sources of erosion problems. The study area is identified in **Figure 1**.

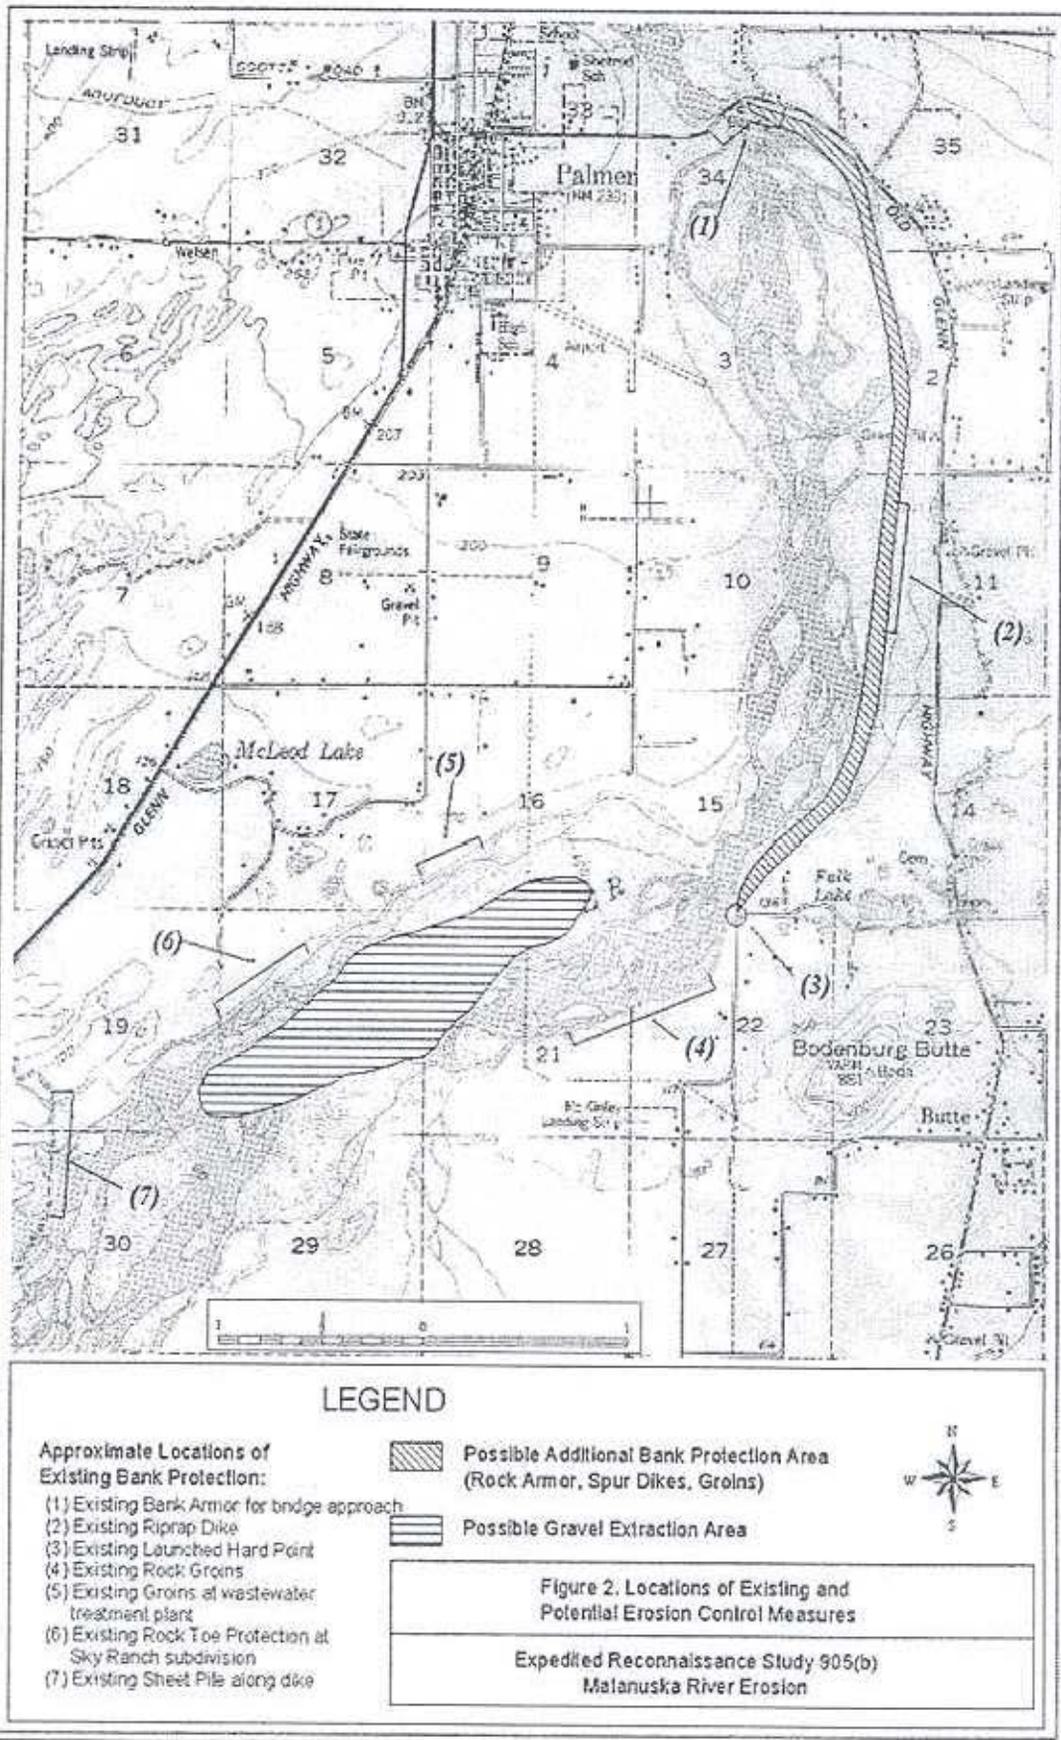
A series of three dikes were constructed along the left bank of the Matanuska River near Ye Old River Road. The first of these dikes, which are armored with riprap, was constructed by the Borough in 1986. Two additional dikes, one upstream and one downstream, were constructed in 1989. All three dikes were constructed to control erosion. Erosion in this area could directly cause damage to several homes in the area as well as indirectly cause damage by connecting the main channel with low lying areas. The latter process would increase flooding. Funding for the 1989 dikes was from the Alaska Department of Emergency Services (Rulison 1989). See **Figure 2, Item (2)**.
