# United States Senate

Enclosed is a copy of the response I received from the Army Corps of Engineers regarding assistance for flooding along the Matanuska River. I wish the response were more positive -- it seems that until a cost-sharing partner can be identified, no Federal funds can be requested. If I can be of any further assistance, please contact me.

The COE's report in summary found the following:

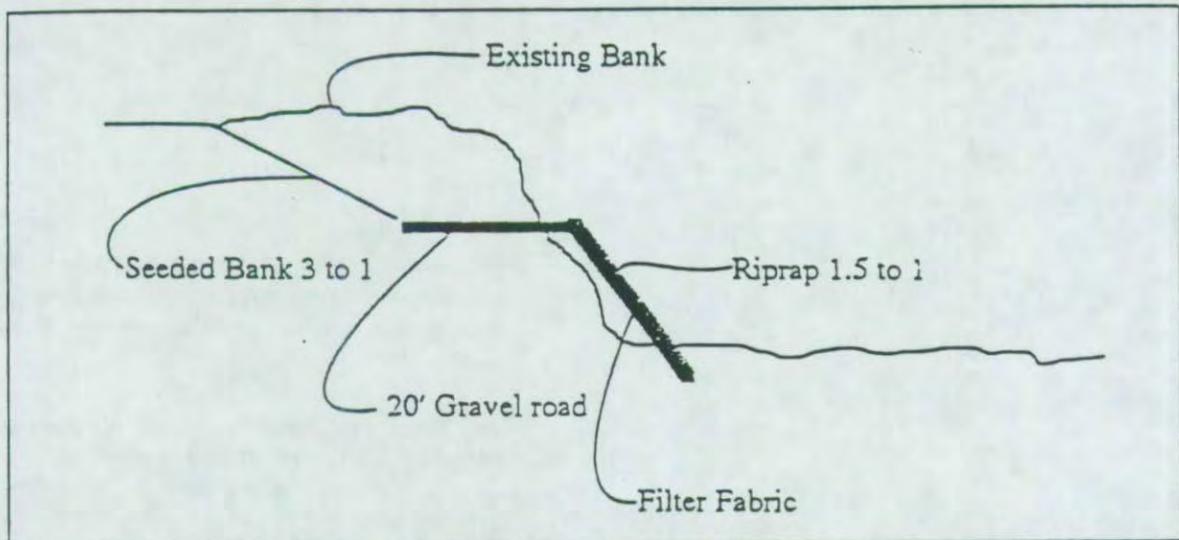
Typical Section

Rock Riprap. Dumped rock riprap is the most widely used revetment. Its effectiveness is well established where adequate size, of suitable size gradation, and properly installed. A cost general review of this design and cost analysis was done using the following typical section:

- Average bank height 20 feet above channel bed elevation
- Scour depth 4 feet below channel bed elevation
- Riprap height 10 feet above channel bed elevation

Based on the above cost estimate the estimated capital improvement cost for protection of approximately 3 miles of the Matanuska River would be \$5,291,444.40 per mile or \$15,874,333.20 for this area of the Matanuska River. Plus general maintenance and inspection costs which have not been estimated for this report.

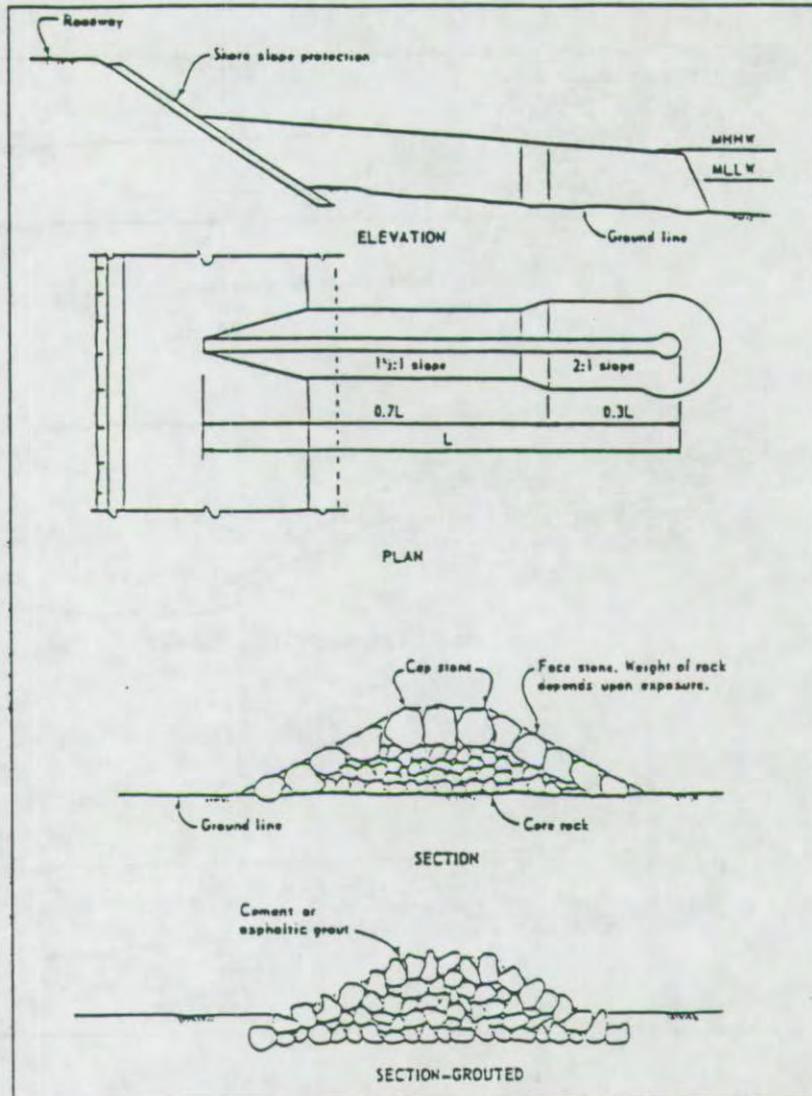
Typical Groin

It should be noted that this solution would provide the needed protection. Care must be made in the design to insure that the design solution does not move the problem either up or down stream of the currently affected area. In general it is felt that these structures would not work in this area because of the Matanuska Rivers instability, and the possibility that the spur dikes would encourage the river to move to the opposite bank.

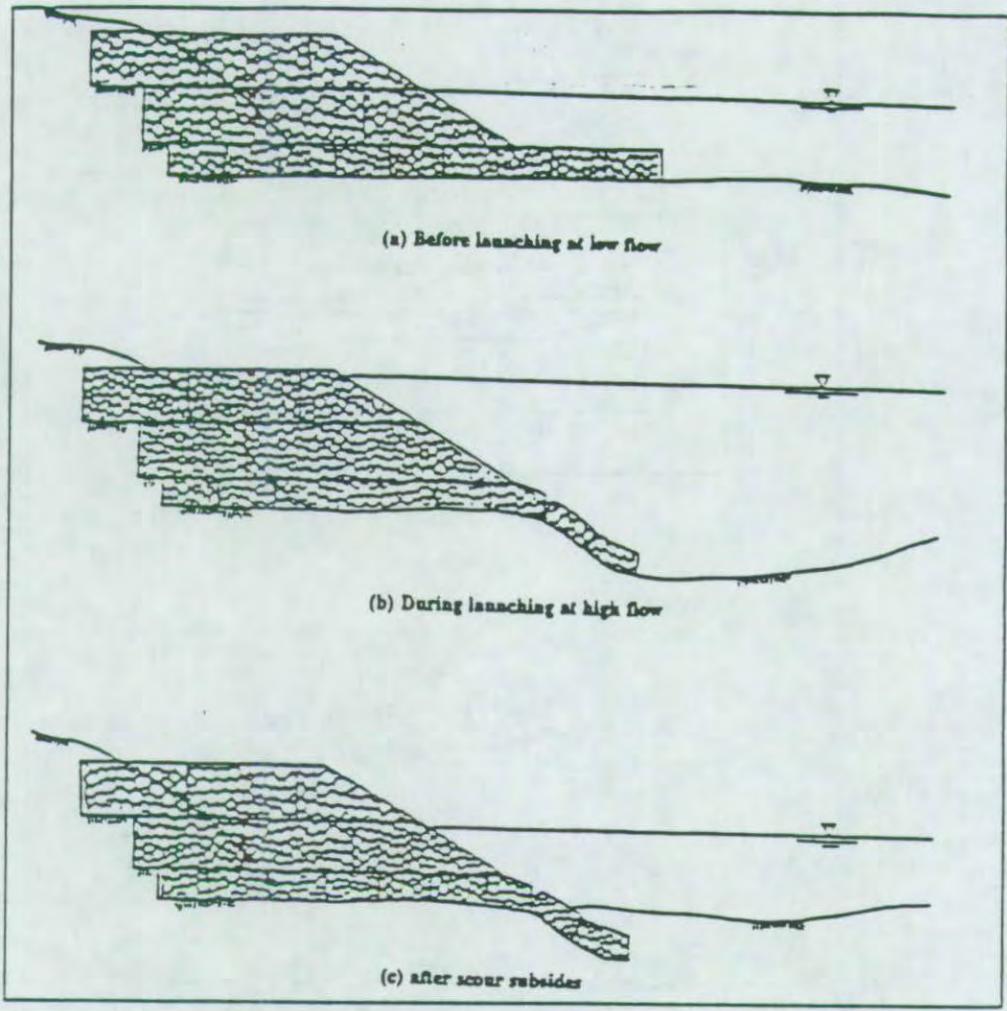
Gabions are in the dimensions of the devices. Gabions rigid structures therefore requiring regular inspection, maintenance, and are subject extremely susceptible to scour failure.

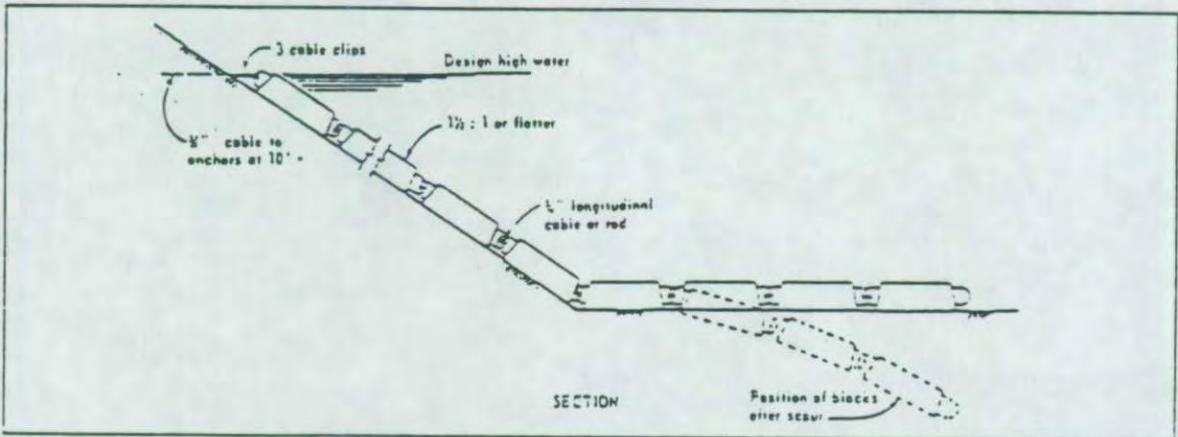
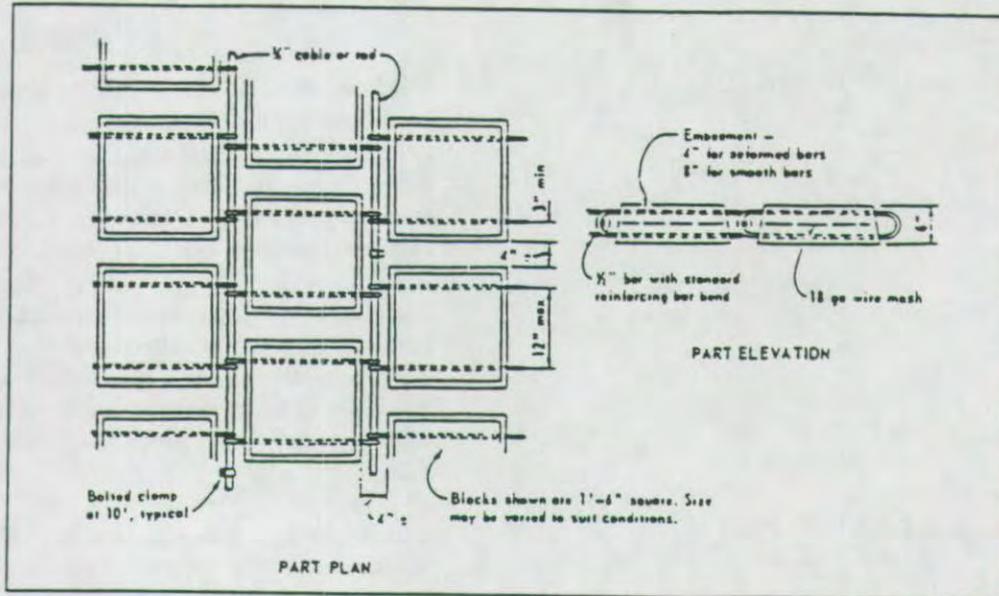
Precast concrete blocks such as Armor Teck have a good track record if they are properly designed. In general, they are more costly than a riprap solution unless riprap of size and gradation is not available.

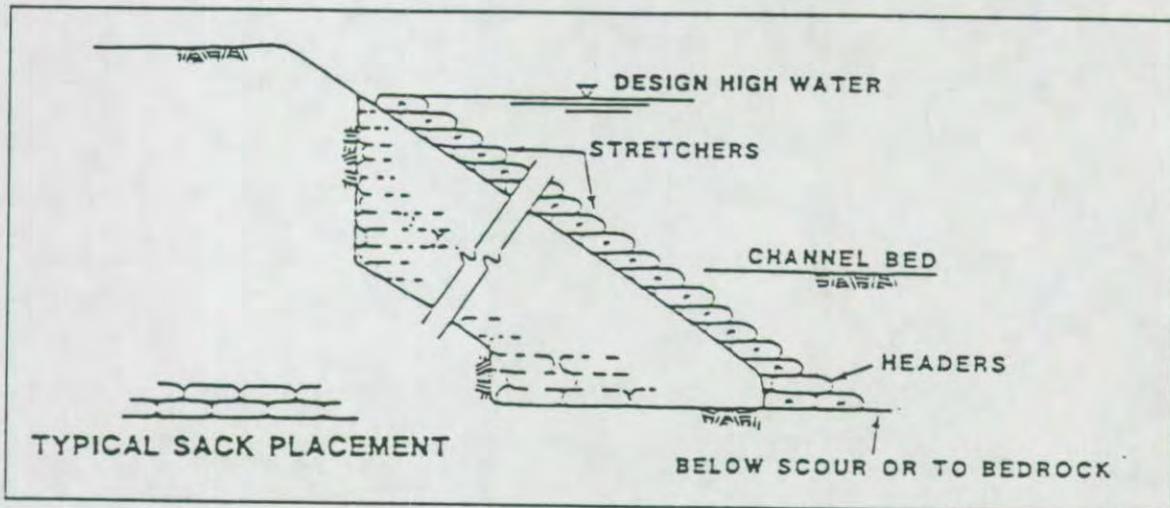
Typical sand-cement bag revetment

This solution is very susceptible to undermining. If any section of the protected area should become undermined the entire structure can fail.

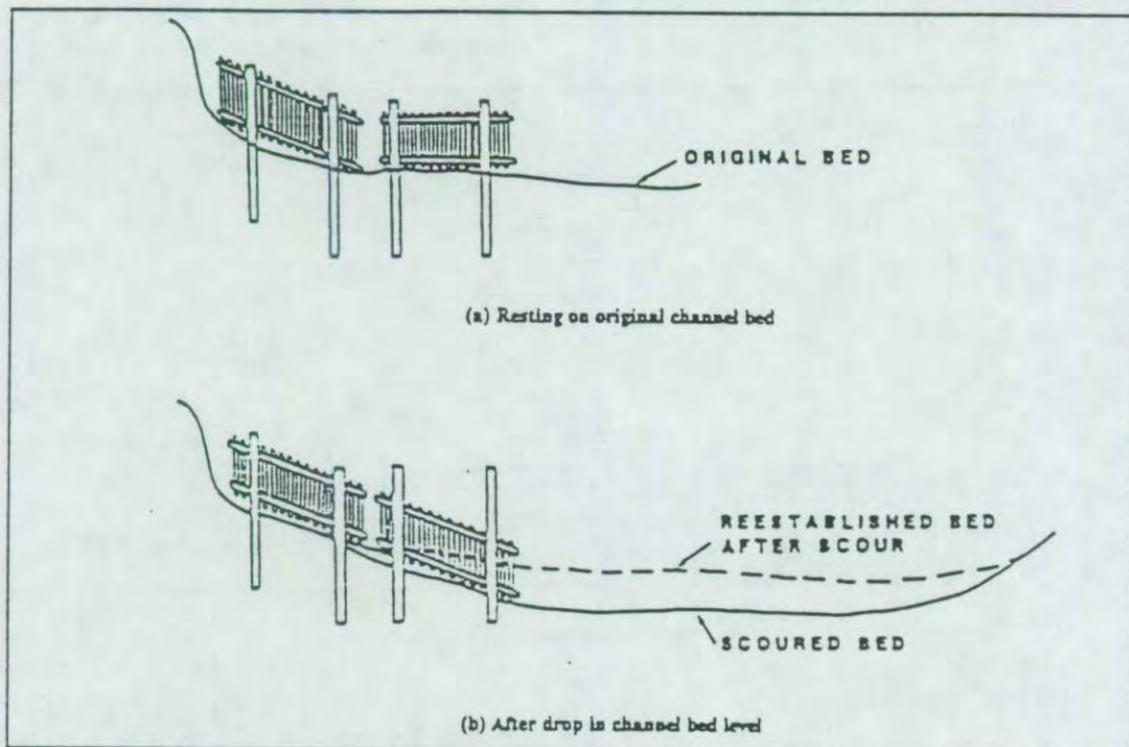
### Henson Spurs

A variety of permeable spur designs are also shown to control bank erosion. There are several case histories where failures experienced at a site that is highly unstable with rapid lateral migration, abundant debris, and extreme scour depths.

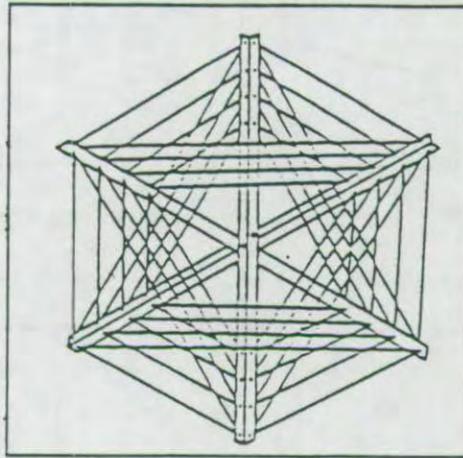
Typical Jack Unit

This system works well in general in grading rivers. The system has been used only works well in "light debris" conditions.

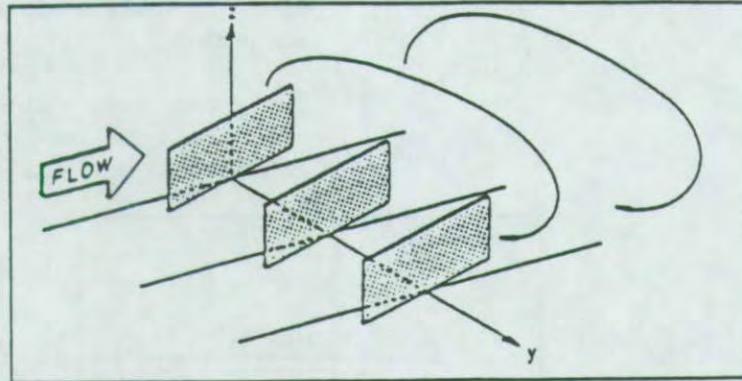
Perspective of an Iowa Vane layout

Vane Dikes are a series of low elevation structures designed to guide flow away from the eroding bank line. The structures can be constructed of rock or other erosion resistant material such as sheet pile. The crests are below the design water elevation and

flow can pass over or around the structures, with the main thread of flow directed away from the eroding bank. These structures have a mixed success history.

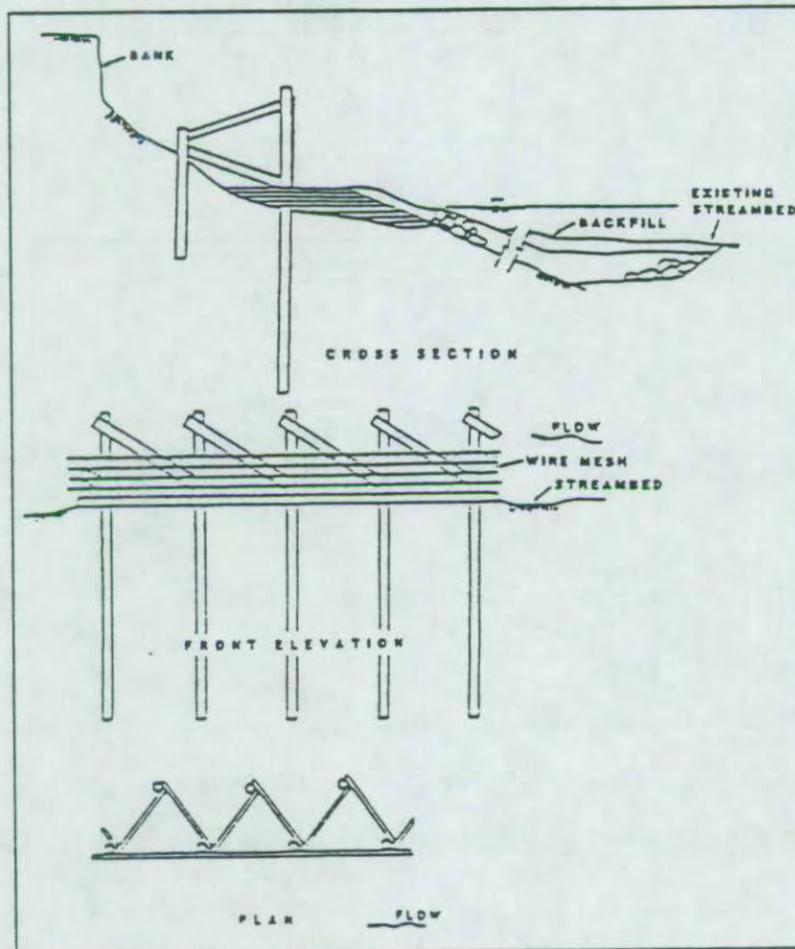
Heavy Timber pile wire fence retarder structures

Heavy timber pile and wire fence retarder structures
