Matanuska River Management Plan

Adopted: September, 2010

Matanuska Susitna Borough
350 E Dahlia Avenue
Palmer, Alaska 99645

missal, llc | a limited liability company

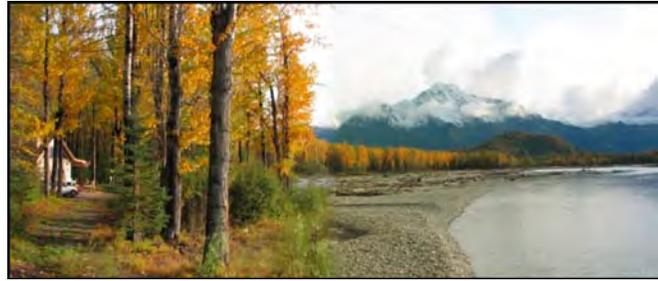
The Matanuska River is eroding the riverbank near Mile 14 Old Glenn Highway threatening area homes. Photo by Scott Easler

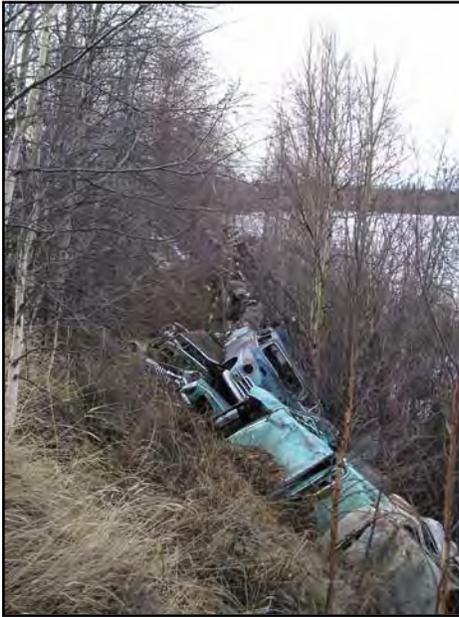
Junk cars have been used unsuccessfully and illegally by private property owners in an attempt to slow erosion along lower reaches of the river.

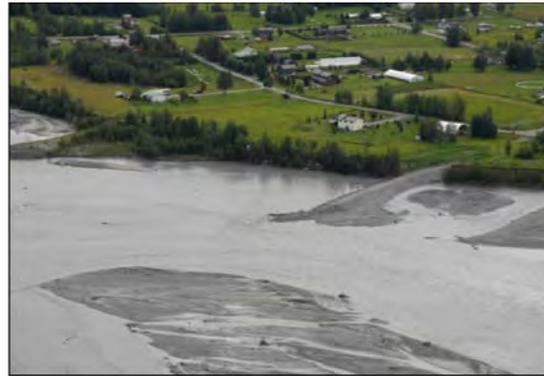
Circle View Subdivision in Butte has a concentration of five finger dikes, like the one shown above, to protect against erosion.

The Circle View and Stampede Estates Flood and Erosion Control Service Area meets quarterly to plan and review river erosion control measures and funds the annual inspection of the five spur dikes to determine if repairs are needed.

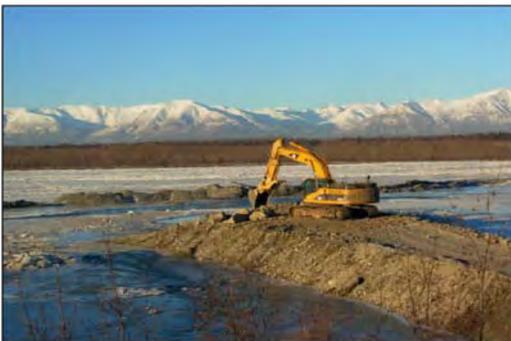
Construction of Dike #5 in Circle View Subdivision.

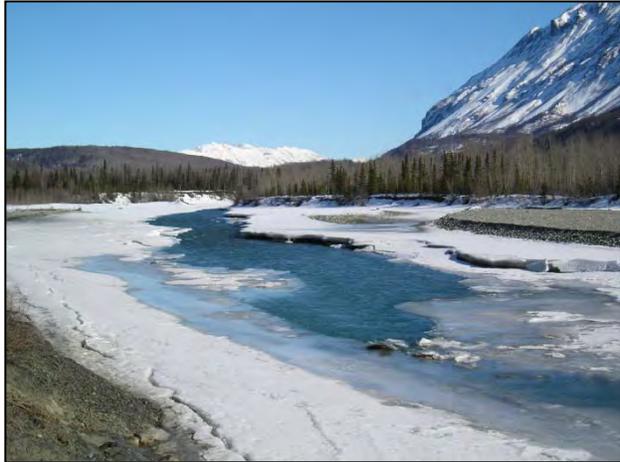
In the Chickaloon area, the Matanuska River is contained by canyon walls and some areas of bedrock, making a narrower, swifter riverbed.

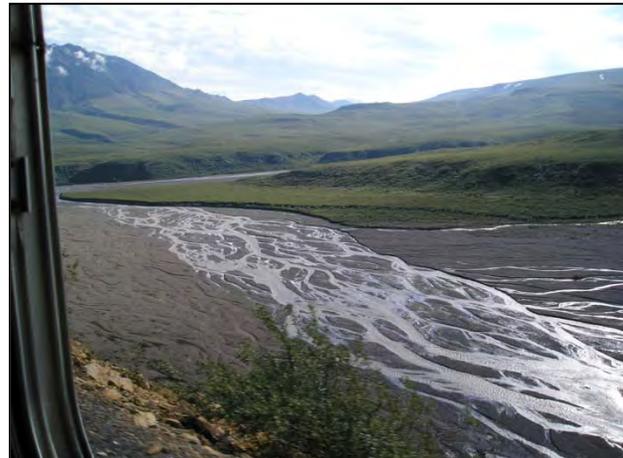
The river corridor near Palmer exhibits the wide, braided characteristics of many glacial rivers.
